TECHNICAL DOCUMENT

Common Problems and Issues Concerning the Samsung FS-5000 (P8E) Toner Cartridges

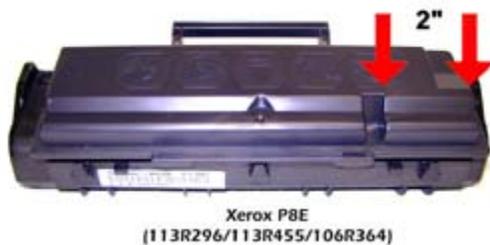
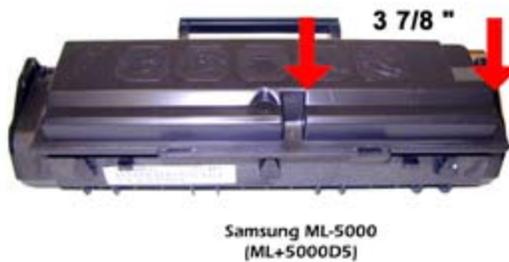
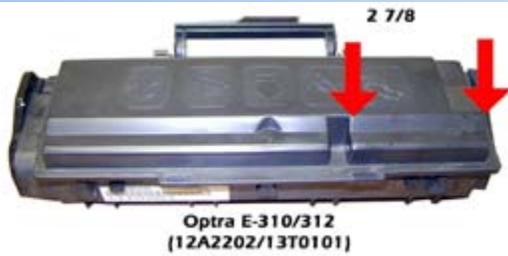
Figure 1

As stated above, the various models listed all use the same supplies to recycle, however the cartridges are not interchangeable. Figures 1-3 show the various styles. Basically, the notch on the leading edge of the cartridge is in a different place for each manufacturer.

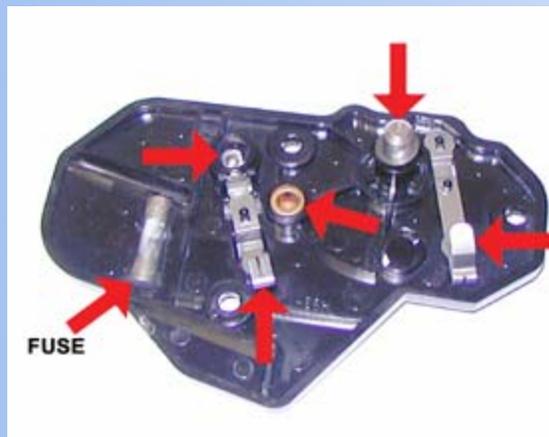
The end cap of all the cartridges houses a small 5 x 20mm, 100ma glass type fuse that must be replaced each cycle. If the fuse is not changed, the printer will not recognize it as a new cartridge. It should be noted that starter cartridges do not have a fuse, they have a black plastic blank shaped like a fuse. See Figure 4

The contacts on the left side of that cartridge must be thoroughly cleaned. We have found that by scrubbing them with the cut down acid brush and alcohol, this problem virtually disappears. Cleaning them with a cotton swab is not enough. The metal tends to oxidize and a good "scrubbing" is needed. After cleaning them, place a very small amount of conductive grease on them. Remember, when it come to conductive grease, more is NOT better. Just place enough on each contact so that it is barely covered. Too much grease will attract toner to it, and actually start to insulate instead of conducting. See Figure's 4 & 5
