Remanufacturing the Xerox 4525 Toner Cartridge

0317

First released in April 2001, the Xerox 4525 is based on a 45 ppm 1200 Dpi engine. While it looks like an N24 cartridge there are differences, but most importantly the toner is different. The higher speed of these machines calls for a toner that melts at a different temperature than the N24. Most of the other parts used in the cartridge are standard N24, but the toner is not.

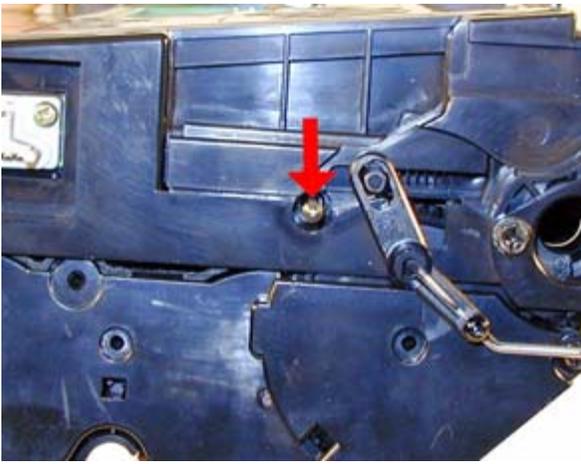
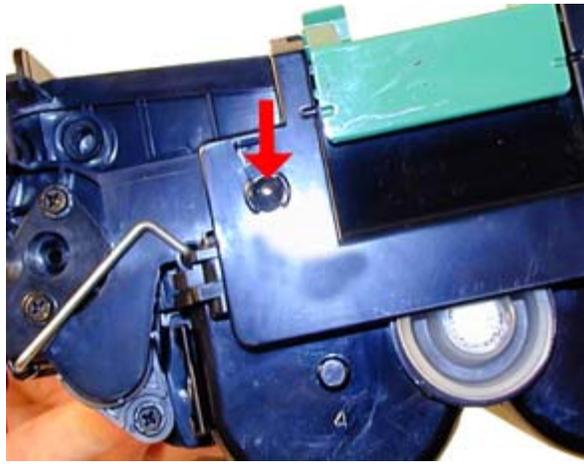
Figure 1

- 1) Vacuum the exterior of the cartridge.
- 2) On each side of the cartridge there is a large metal pin.
- 3) Carefully pull these pins out using either a pair of needle nose pliers or wire cutters. See Figure's 1 & 2
- 4) Remove the Waste Chamber and put the toner hopper aside. See Figure 3
- 5) Remove the two screws on each side of the drum axle plates, remove the Plates. See Figure's 4 & 5

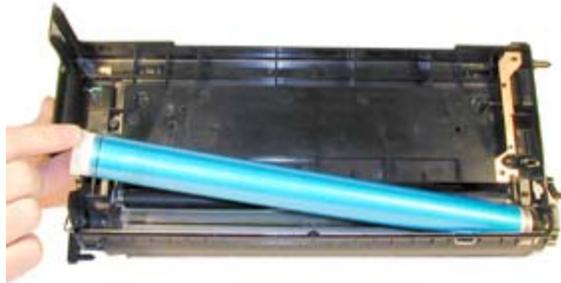
6) Remove the Drum from the cartridge. See Figure 6

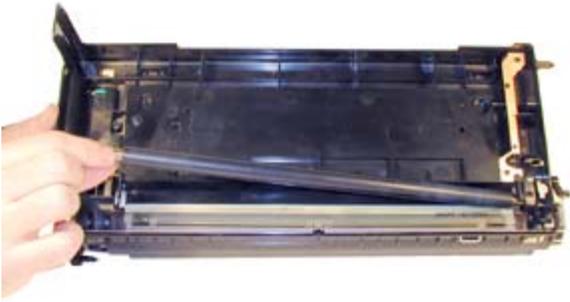
7) Remove the Primary Charge Roller (PCR). Clean with your preferred PCR cleaner. See Figure 7

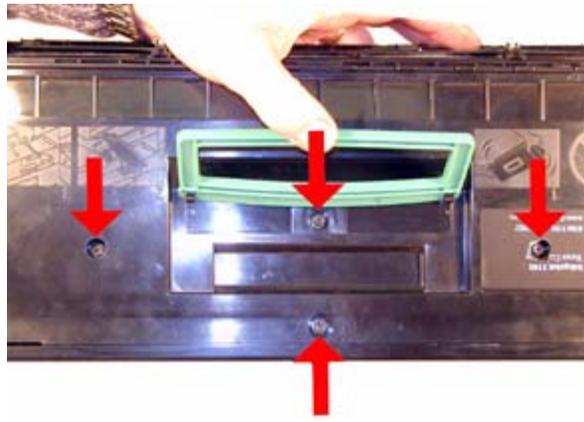
8) Remove the top cover of the Waste Chamber by removing the 4 screws. One is hidden under the label, and one is under the handle. See Figure 8

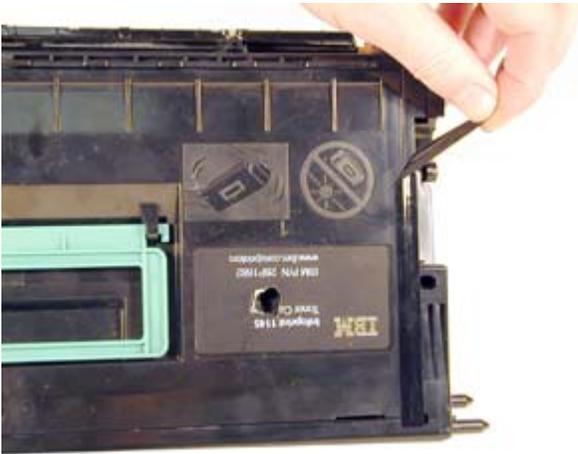
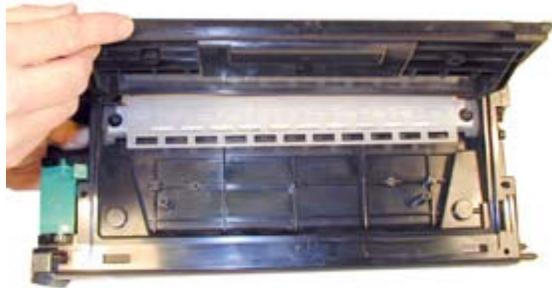
Figure 9

9) Remove the tape seal from the right side. Pry the cover up from the bottom edge. See Figure's 9 & 10

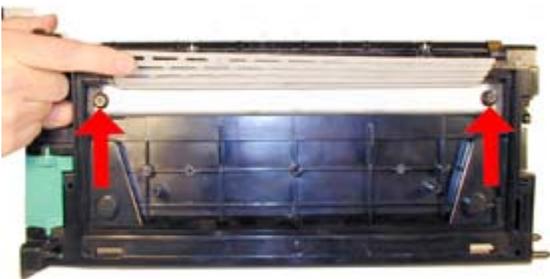
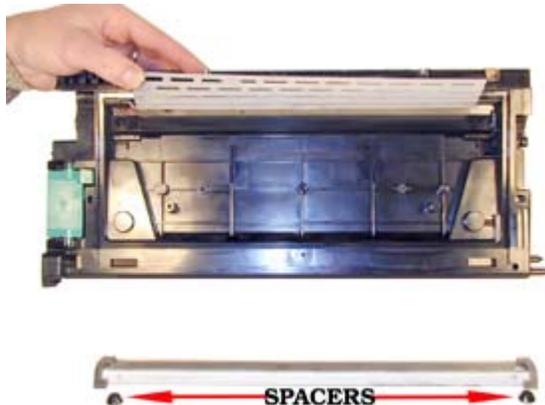
Figure 11

11) Remove the Wiper Blade (2 screws and spacers, lift up and out). DO NOT lose the spacers! This blade has a tight fit, work it loose from both edges and lift out. See Figure's 11 & 12

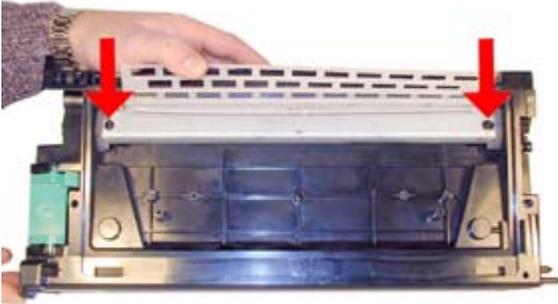
12) Coat the NEW wiper blade with your preferred lubricant and install. See Figure 13

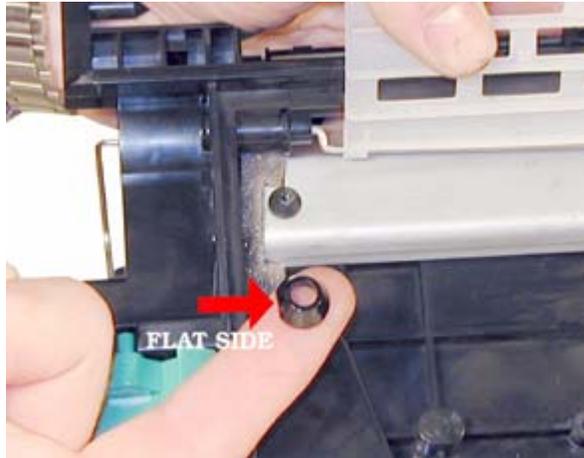
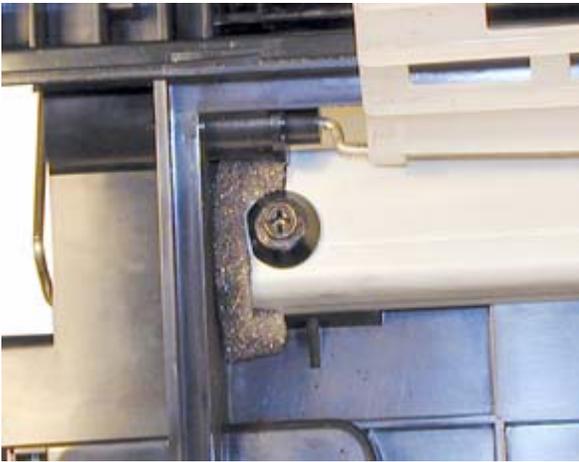
Figure 14

13) Replace the two screws and spacers. Make sure the flat side of the spacers is facing the foam. That way the foam will not be pinched by the spacer possibly causing a leak. See Figure's 14 & 15

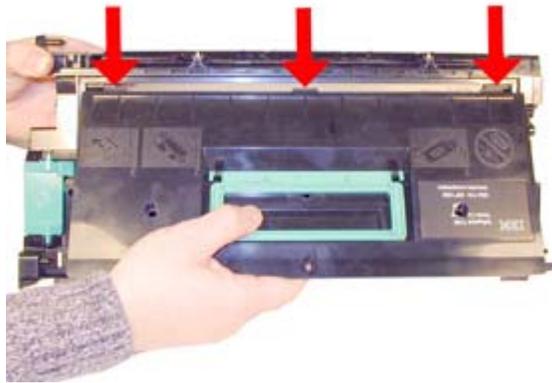
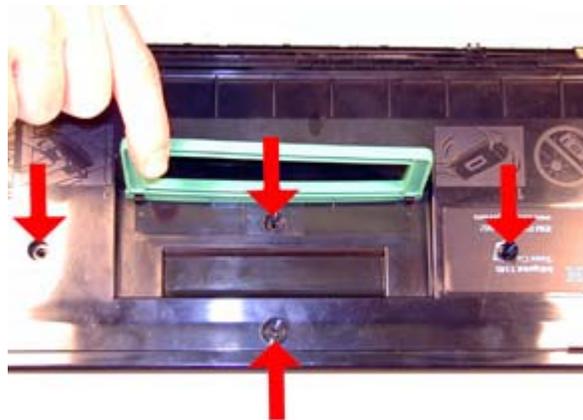
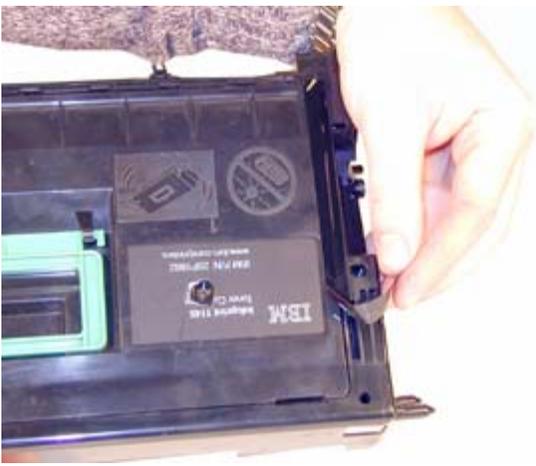
Figure 16

14) Install the top cover front edge first. Press down so the back tabs lock in place, install the four screws, and the tape seal on the right side. See Figure's 16, 17 & 18

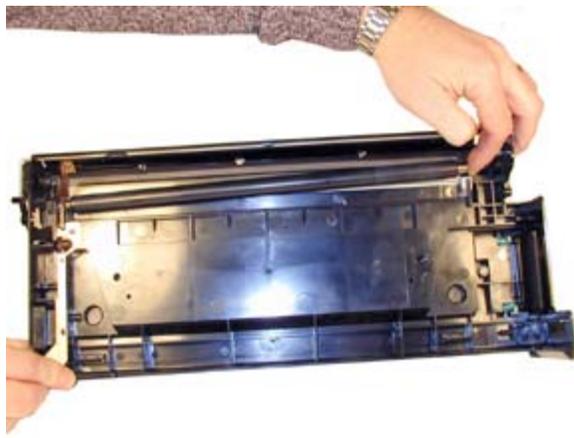
15) Install the cleaned PCR. See Figure 19

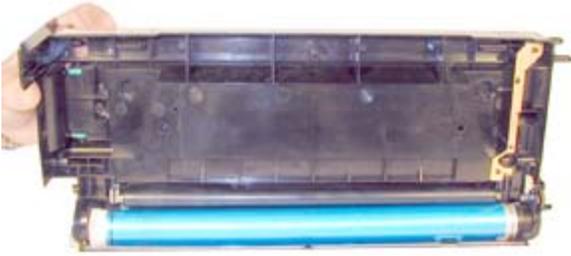
16) Install the white gear side of the drum to the white PCR holder side of the cartridge. See Figure 20

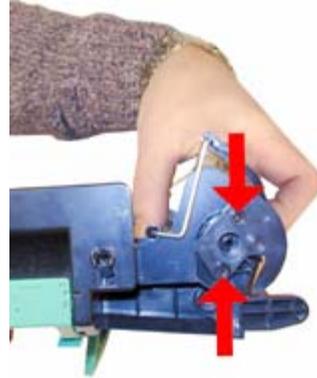
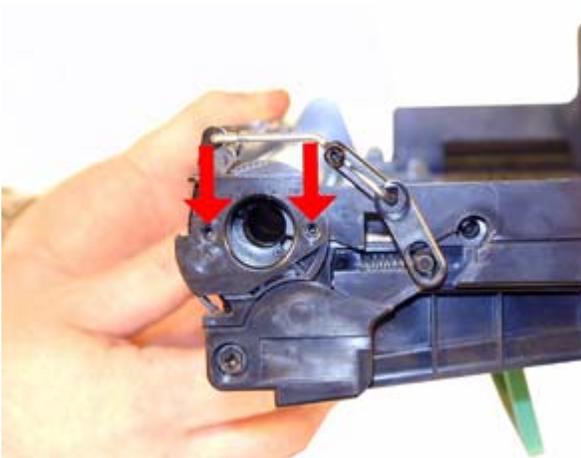
Figure 21

17) Install the two drum end caps, and screws. See Figure's 21 & 22

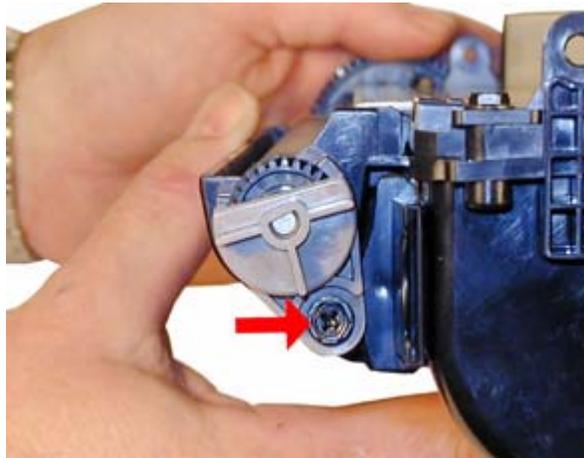
19) On the small drive gear side of the supply chamber, remove the screw, and Magnetic roller end cap. See Figure 23

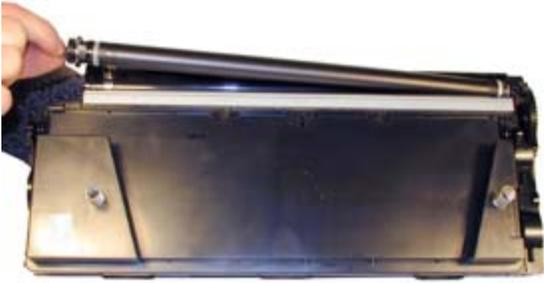
20) Carefully remove the magnetic roller, vacuum clean and place aside. See Figure 24

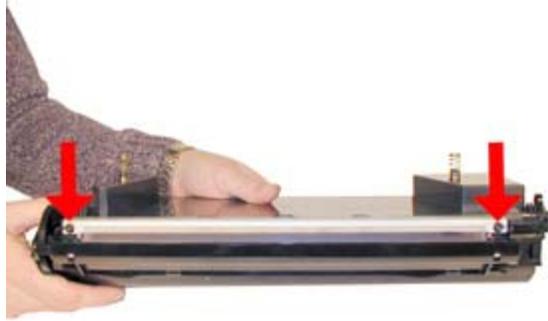
21) Remove the two screws and DR blade. See Figure 25

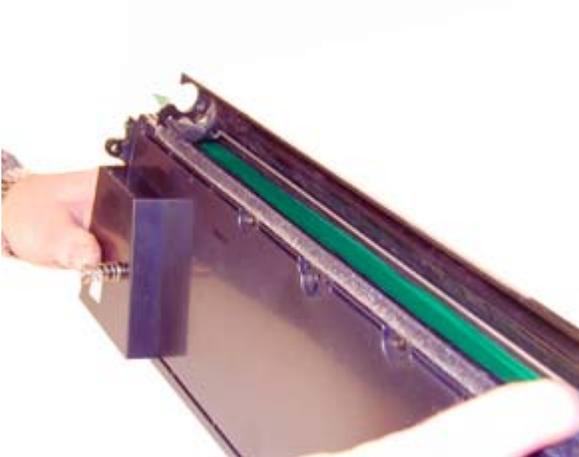
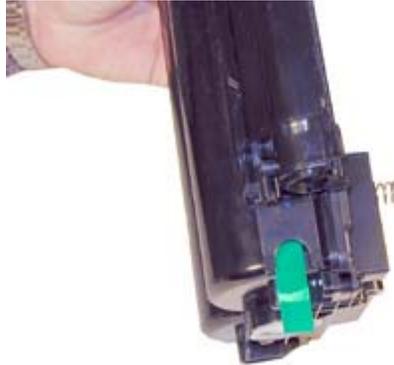
Figure 26

23) Install the seal so that the tail is on the small drive gear side. Make sure the tail fits into its slot, and comes out through the seal channel. See Figure's 26 & 27

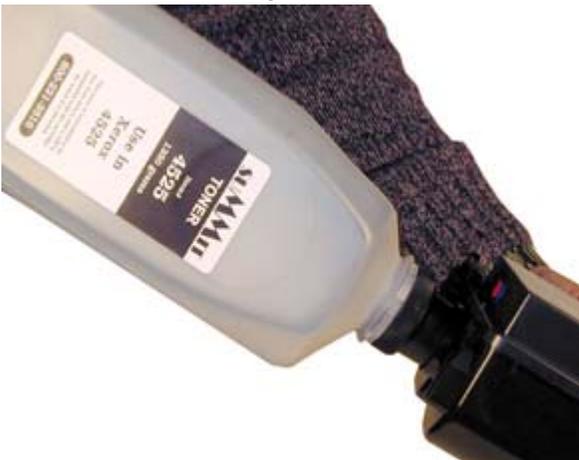
24) Fill the hopper with 1350g of dedicated W820 toner. As explained in the beginning of this article, normal N24 toner will not work in these cartridges due to the higher printing speed of the machines. Check for leaks. See Figure 28

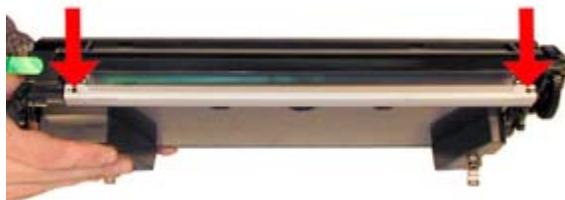
25) Replace the DR blade and two screws. See Figure 29

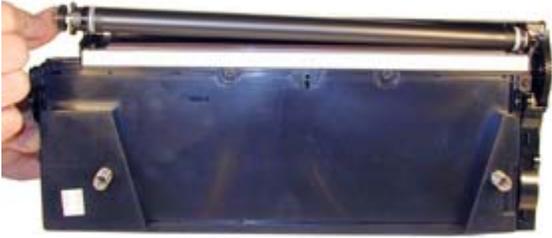
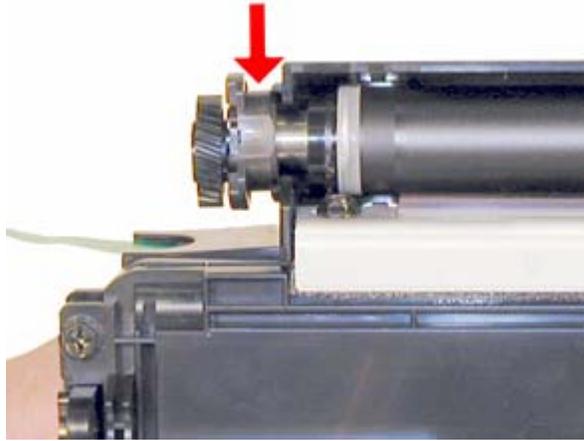
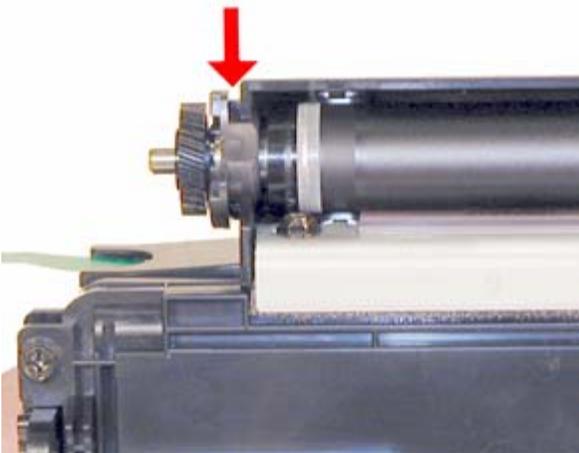
Figure 30

26) Turn the bushing on the magnetic roller assembly so that the curved side is facing up. Pull it away from the roller slightly, and install the entire assembly into the hopper. Press the bushing in so that it is seated properly, and press the drive gear back on the keyed shaft. See Figure's 30, 31 & 32

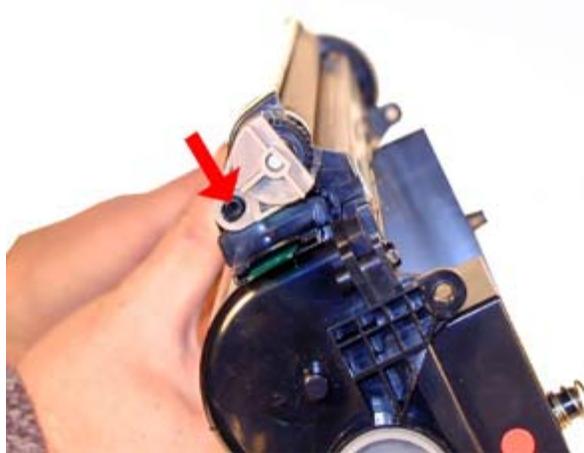
27) Install the end cap and screw. Note that both the end cap and Magnet shaft are keyed. Make sure that the roller turns freely. See Figure 33

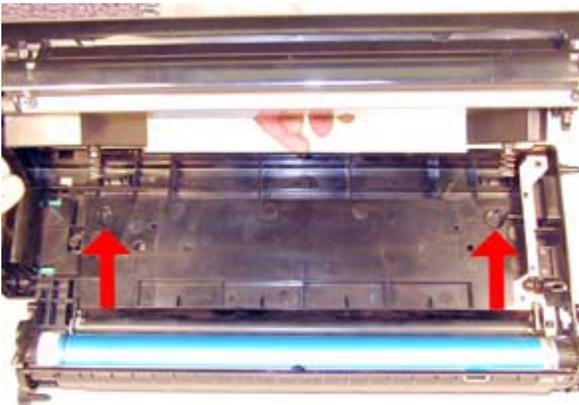
28) Re-assemble the cartridge by placing the two halves together. Make sure that the springs fit into their respective holes. See Figure 34

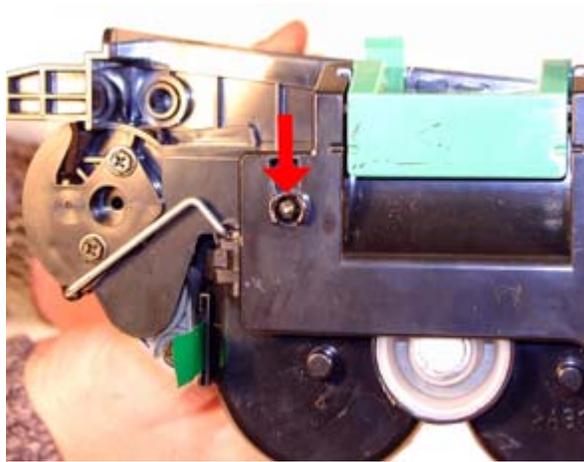
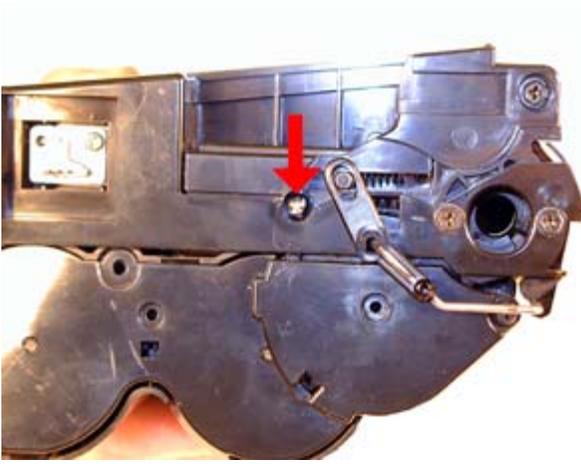
Figure 35

29) Install the two large hinge pins into each side. See Figure's 35 & 36

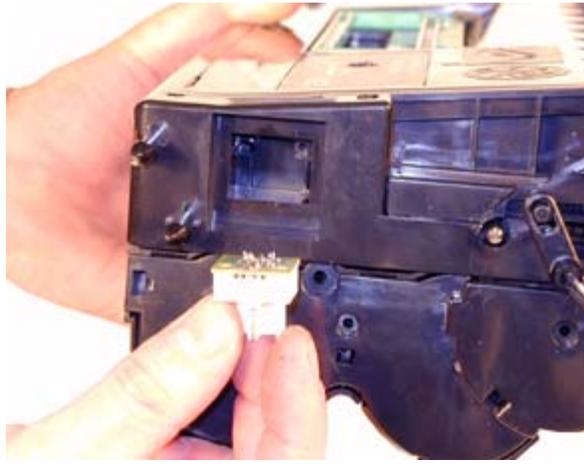
30) Replace the chip with the correct chip for your cartridge. The IBM 1145, Lexmark W820, and Xerox 4525 all use different chips. See Figure 37

These cartridges all use N24 type chips that must be replaced each cycle. Each cartridge has its own chip. Make sure you know which machine your customer has before installing the chip. The cartridge will not print if the wrong chip is installed.
