BROTHER® HL 2170W • TN 360 TONER CARTRIDGE REMANUFACTURING INSTRUCTIONS

REMANUFACTURING THE BROTHER HL 2170W SERIES TONER CARTRIDGE TN-360

By Mike Josiah

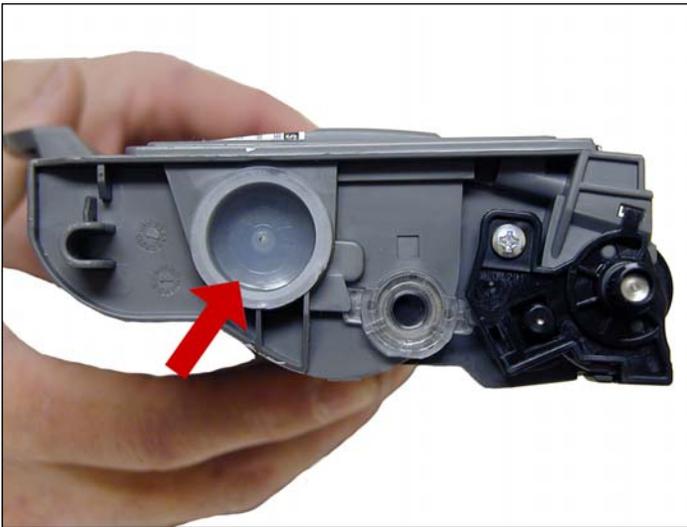
1. Vacuum the exterior of the cartridge.

2. Remove the fill plug from the toner cartridge. Dump the remaining toner and vacuum/blow out the cartridge. Make sure that the gear area is clean. Leaving any toner in the teeth of the gears may cause a tooth to be damaged and cause a clicking noise. We have found it best to use compressed air to clean them out, but to also keep one hand over the gears to protect them.

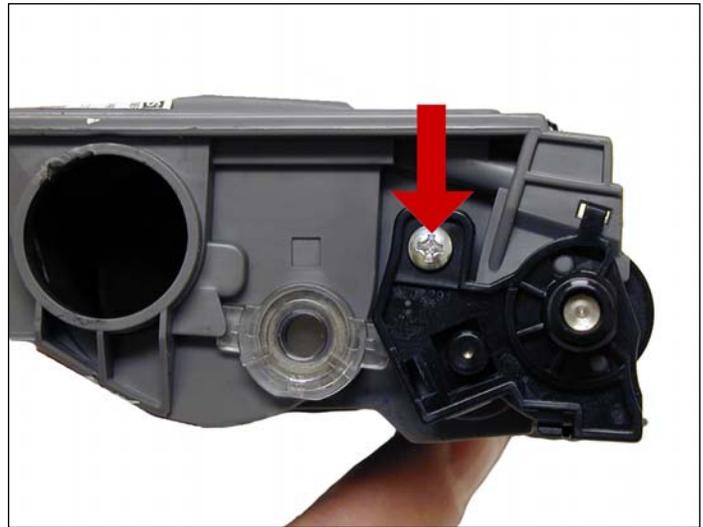
3. On the NON GEAR side of the developer roller, remove the screw.

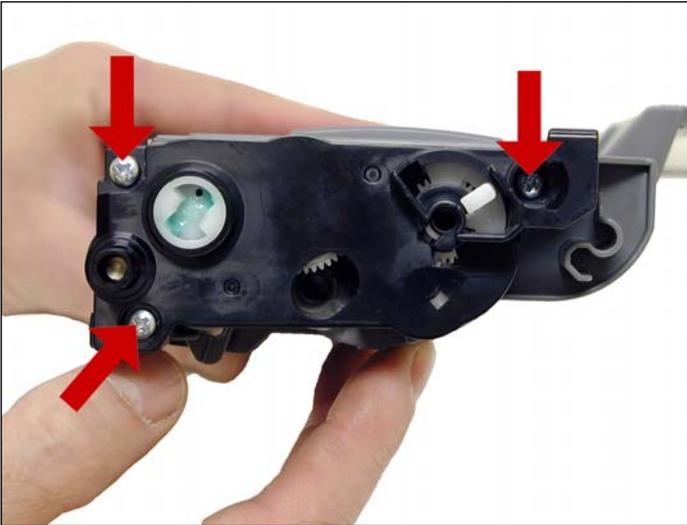
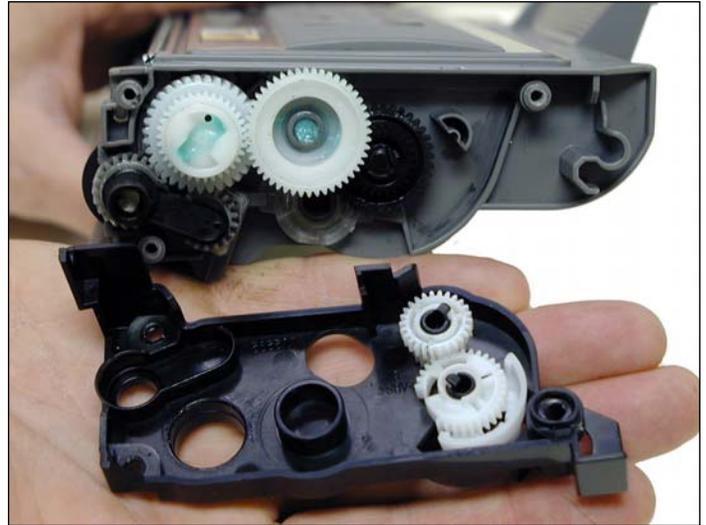
6. The reset gears are attached to the cover plate. These gears reset the printer when a new cartridge is installed. New starter cartridges do not have these gears. New replacement gears are being developed now but until they are available, the starter cartridges cannot be remanufactured.

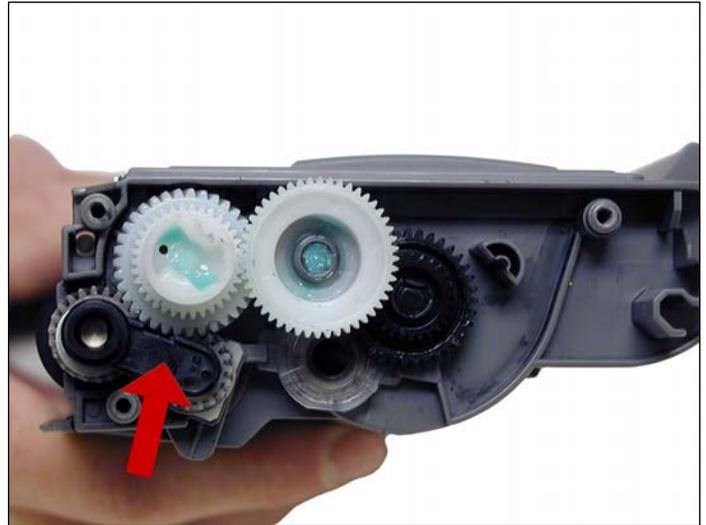
8. Remove the E-Ring, and small gear.

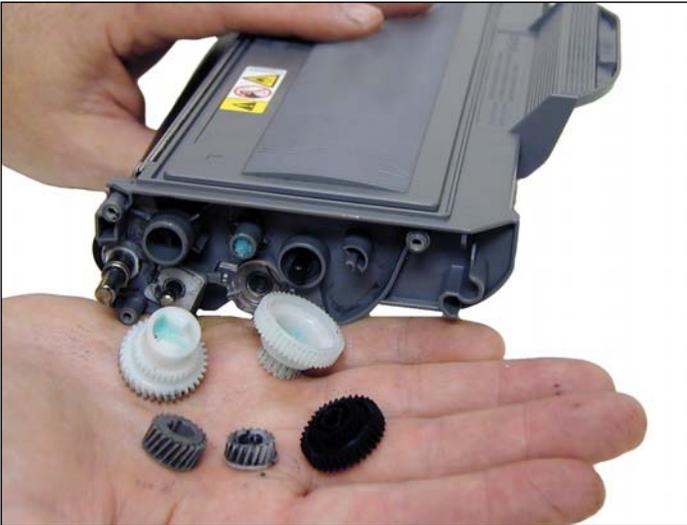
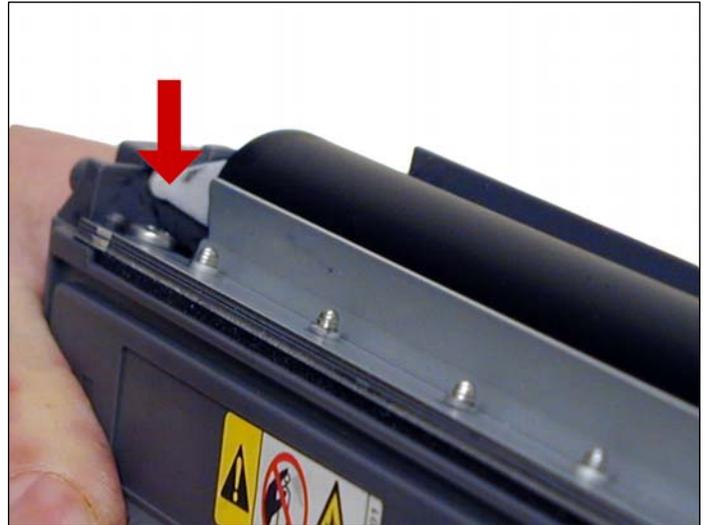
10. On the gear side of the developer roller, press in on the locking tab, and rotate the developer roller lock up.

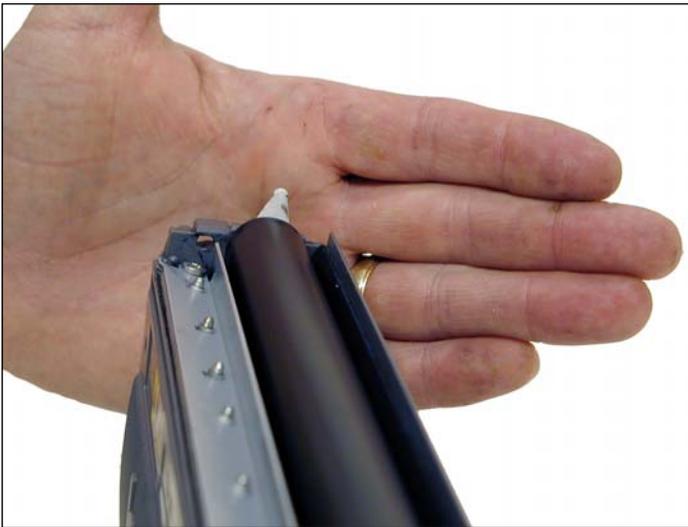
11. Remove the developer roller.

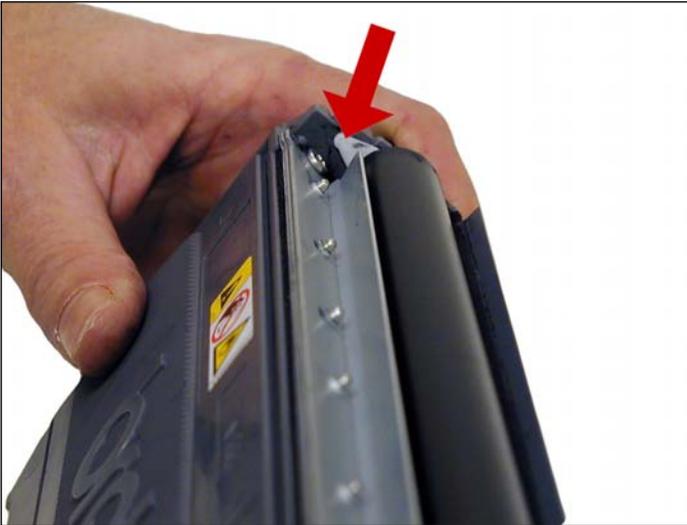
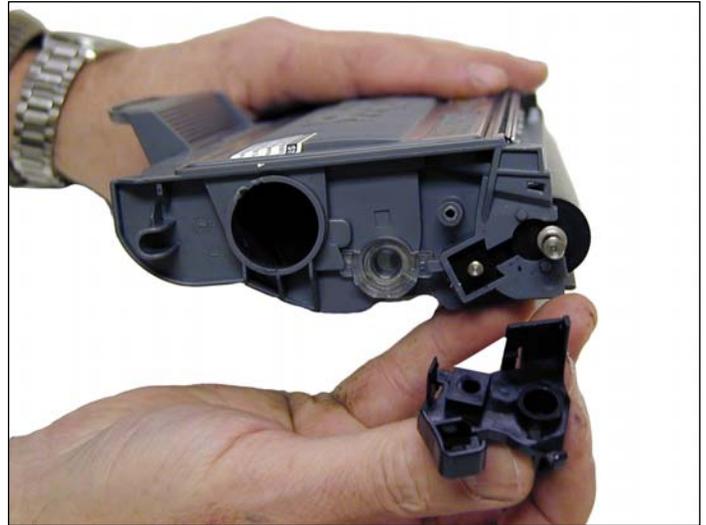
16. Install the small outside end plate and screw on the non-gear side. Make sure the clear plastic plug for the optical sensor is locked in the proper position.

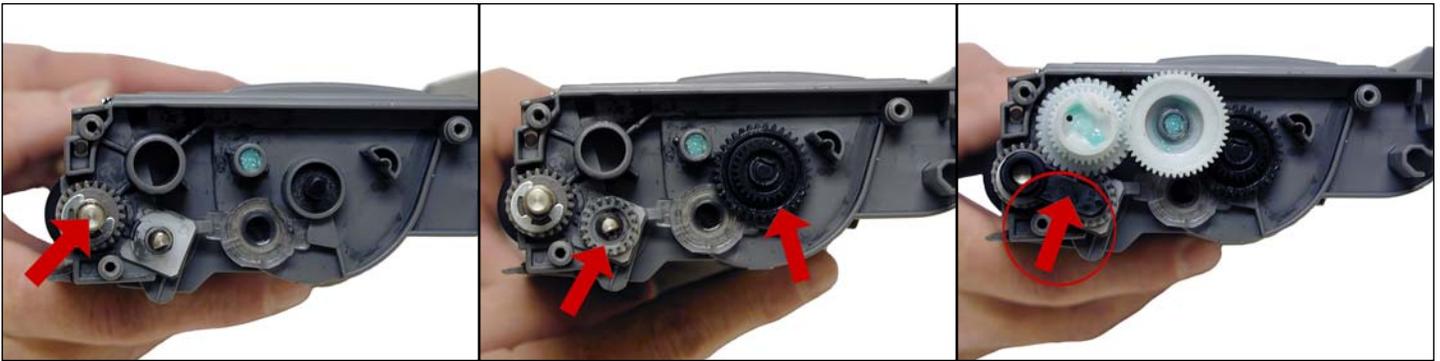
18. Install the developer roller gear, c-ring, black axle spacer, and the rest of the gears. Install the two large white gears last. Make sure all the gears are meshing properly.

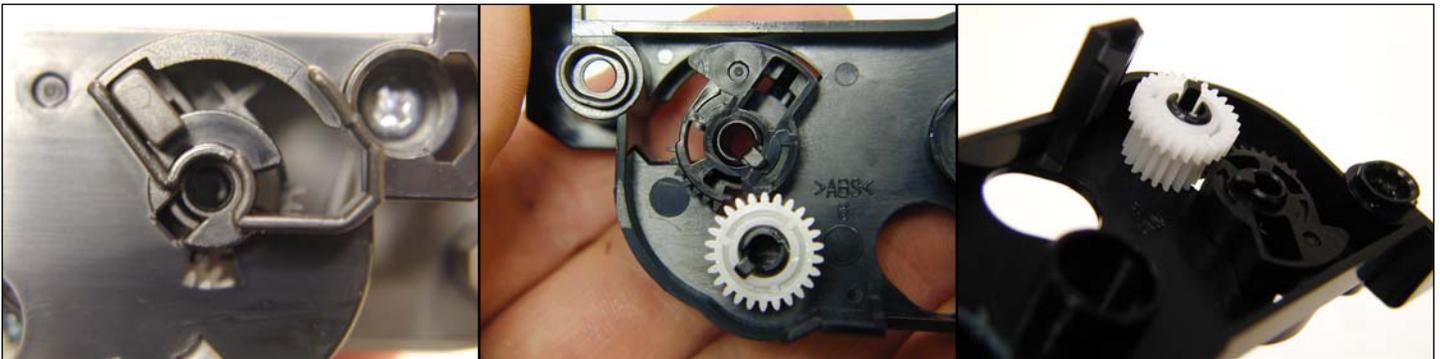
TN-330

19. Depending on the cartridge you have, set the two reset gears as shown:

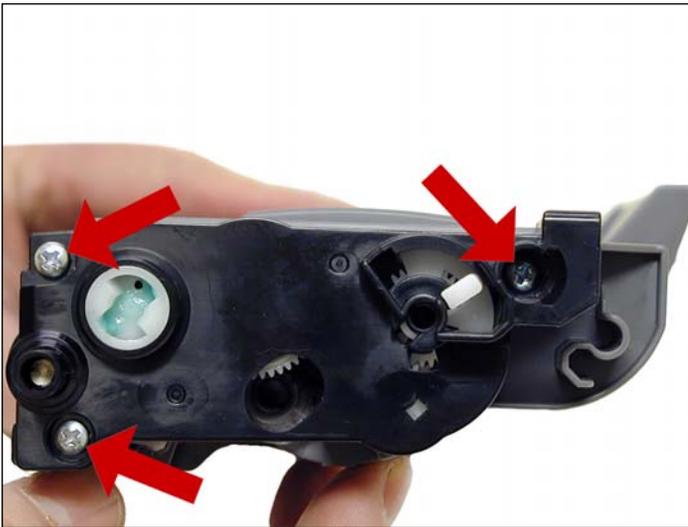
20. Install the gear cover plate, and three screws.

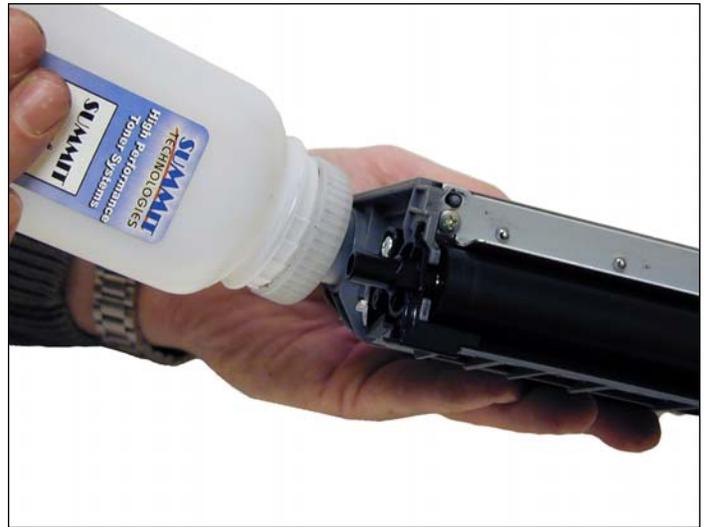
21. Fill the cartridge with Brother 2170 Black Toner

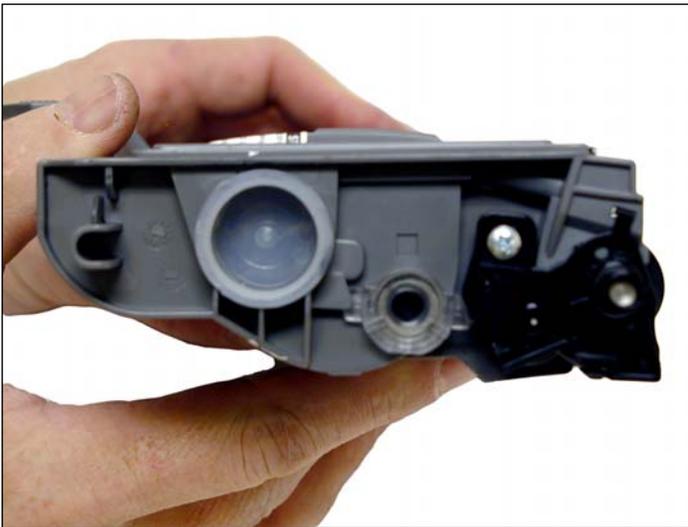
22. Replace the fill plug.

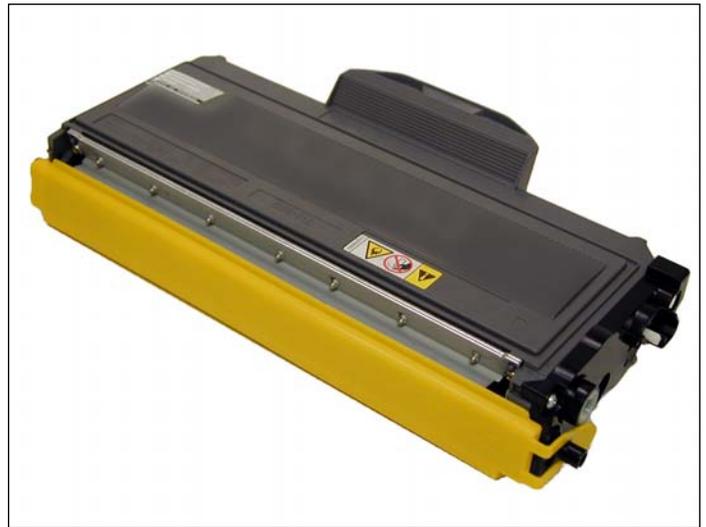
24. Install the developer roller cover.
