Brother HL-7050 DR-700 OPC Cartridges

DOC-0326

OVERVIEW

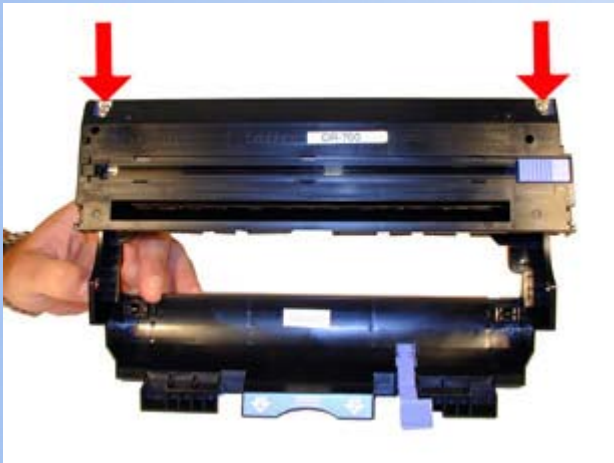
FIGURE 1

1. Remove the top two screws See Figure 1
2. There are two tabs, one on each side of the cartridge. Press them in and lift up the top cover slightly. See Figure 2
3. Pry up the two tabs on the back side of the cartridge. See Figure 3
4. Carefully lift off the cover. It may be necessary to press the top tabs down again when lifting the cover. See Figure 4

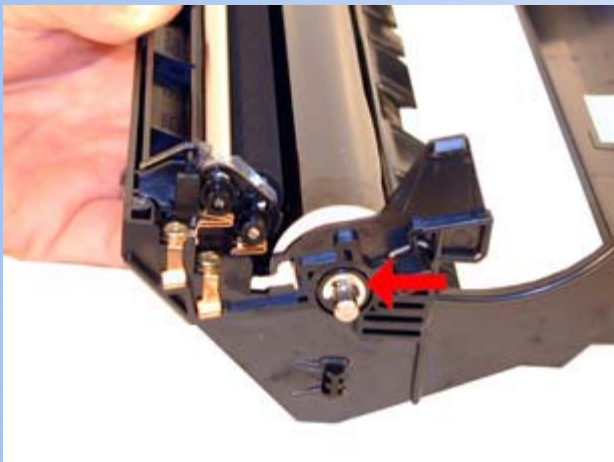
FIGURE 5

5. Remove the E-ring from the Non Gear side of the drum axle shaft. See Figure 5
6. Press the axle out about 1/4" from the cartridge. Remove the opposite E-ring. See Figure 6
7. Remove the drum axle from the Non Gear side of the drum. If you try to pull it out from the gear side, the shaft will jam up on the drum ground contact and damage the contact. See Figure 7
8. When the drum axle is removed, most likely the small drum bushing will come loose. Remove the bushing and place aside so it does not become lost. See Figure 8

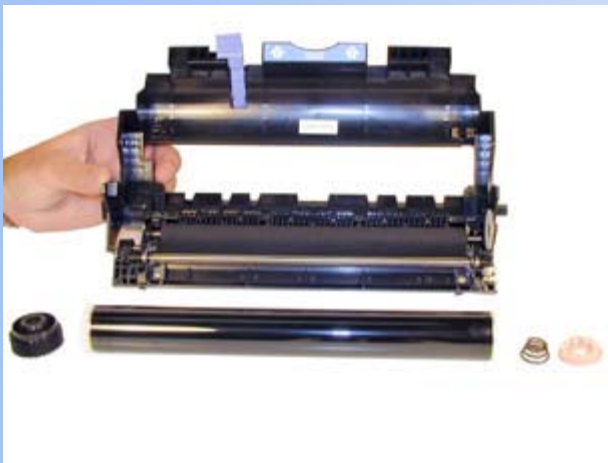
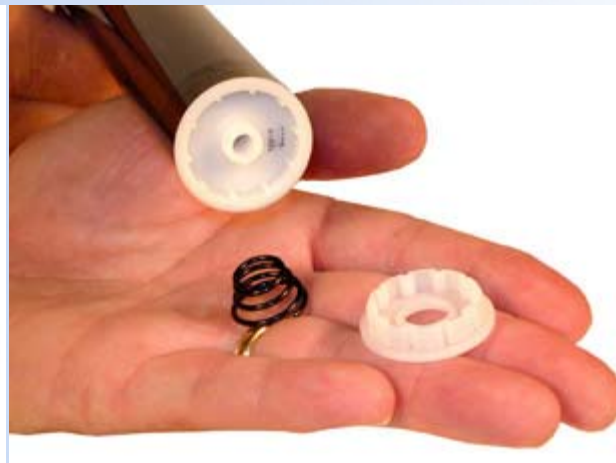
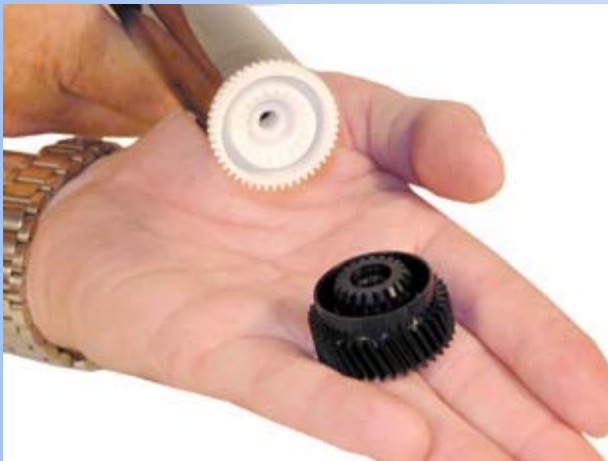
9. Carefully remove the drum. Note that the gear side actually has two gears. One attached, one not. The opposite side has a separate hub and spring. Do not lose these parts! See Figure's 9, 10, and 11
10. Carefully lift out the transfer Roller. The two U-shaped rollers will come out with the roller. Be very careful not to touch the roller with your skin. As with any transfer Roller, the oils naturally present in your skin will be absorbed by the roller and interfere with the transfer process, causing light print. See Figures 12 & 13

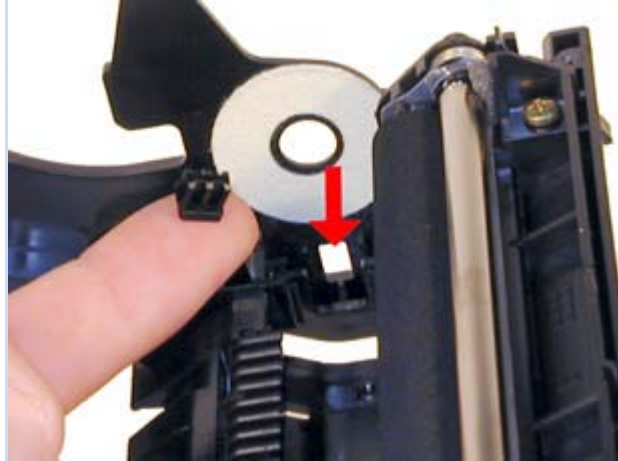
FIGURE 14

11. Remove the small black spacer from the left side of the cartridge. This spacer presses against the shaft of the developer roller, and is easily lost. The cartridge will not function properly with out it. See Figure 14
12. With compressed air, blow off the Transfer roller. Unless you have a statically grounded vacuum, do not vacuum this roller.
13. Remove the two screws from the cleaning roller assembly, remove the assembly. See Figure 15
14. Vacuum or blow off the foam cleaning roller. Take care not to loose the two small black gears. They can come loose during cleaning. Make sure you remove any remaining toner from the pores of the foam. Be very careful not to damage

Light Print: This can be caused by a missing small spacer for the transfer roller. Without this spacer, the roller shaft will not touch its contact properly. This can also be caused by a dirty or worn transfer roller. So far in our tests, the transfer roller should last at least 2 cycles.

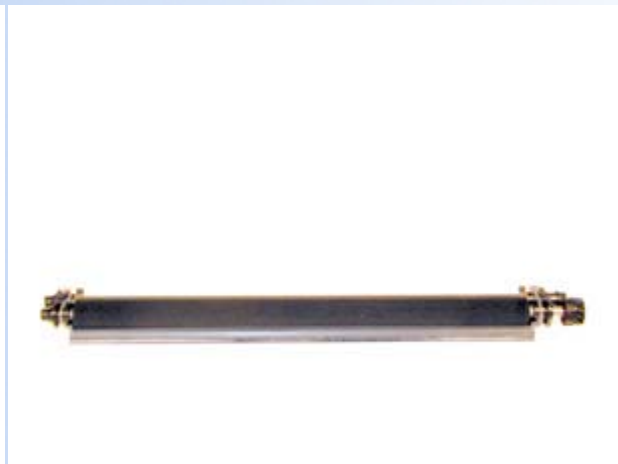
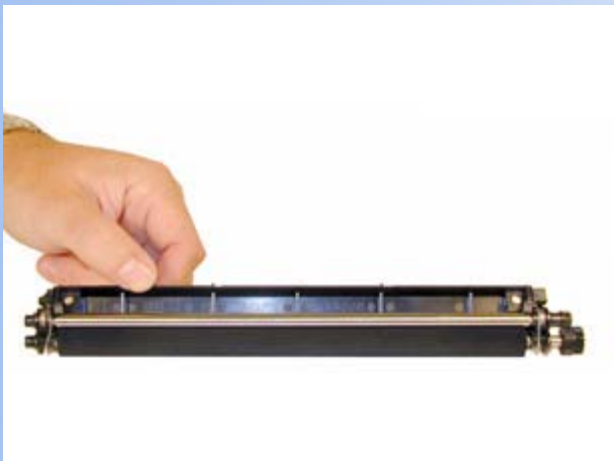
the recovery blade located next to the cleaning roller. If there is any toner on the metal roller, scrape it off with a piece of hard plastic, until the roller is clean. Do not use any chemicals of any type on either roller. They will react with either the toner or the roller and ruin the cartridge. Vacuum any remaining toner from the rest of the assembly. The rollers can be removed from their housing, but we have found it not to be necessary. See Figures 16 & 17

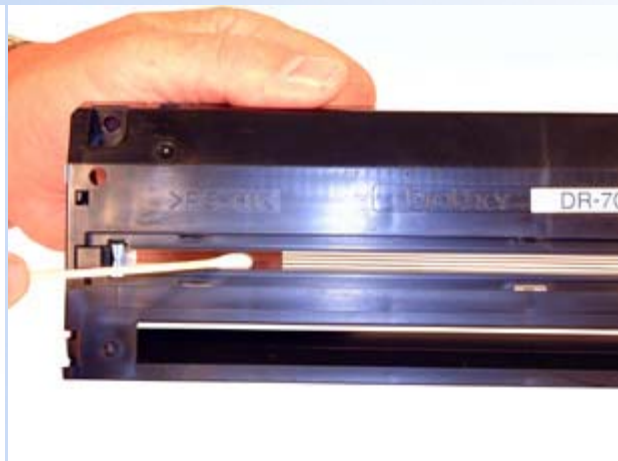
FIGURE 18

15. Clean the primary corona wire and grid located in the top cover, with a cotton swab and alcohol. See Figure 18

Dark Black Vertical Streaks: This is normally caused by either a dirty primary corona wire, or the blue corona wire cleaner is not in its "home" position on the right side of the cartridge.

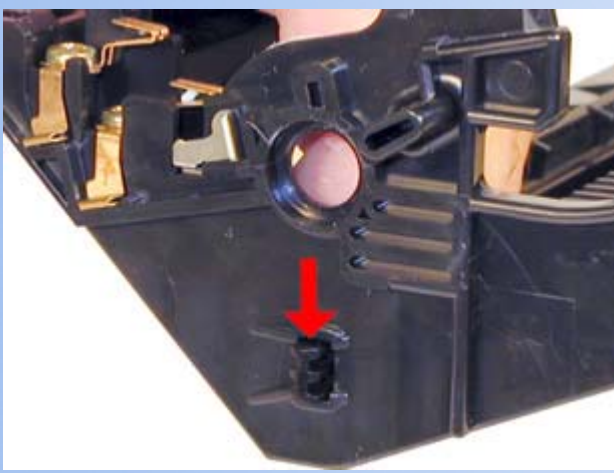
FIGURE 19

16. Install the small black transfer roller spacer into its slot on the left side of the cartridge. See Figure 19

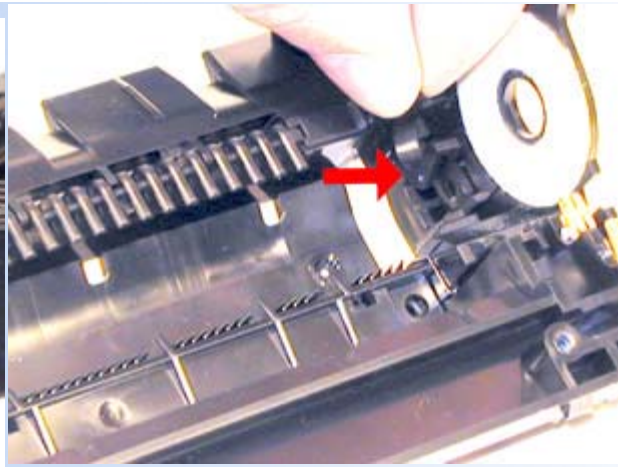
FIGURE 20

17. Remove the two U-shaped holders from the transfer roller, and install in their slots. See Figure 20

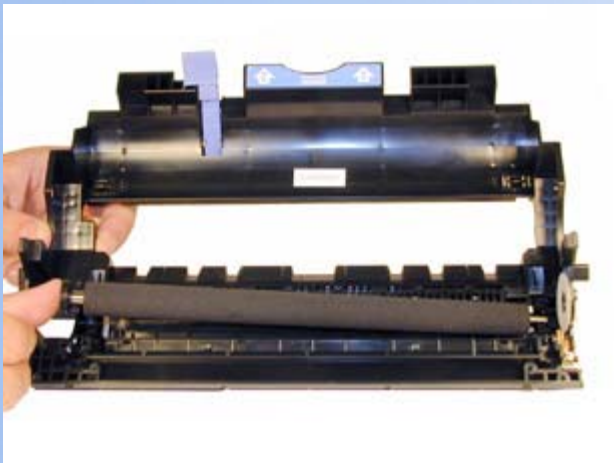
FIGURE 21

18. Being careful not to touch the transfer roller with your fingers, snap the roller into place. See Figure 21
19. Install the drum, gears and spring. See Figure 22
20. Install the drum axle gear side first and "E" ring on that side. See Figure 23
21. Install the small round drum bushing into its place on the non-gear side of the cartridge, Install the remaining E ring. It may be necessary to press the cartridge down on the drum axle in order to see the slot for the E ring on the axle shaft. See Figure 24

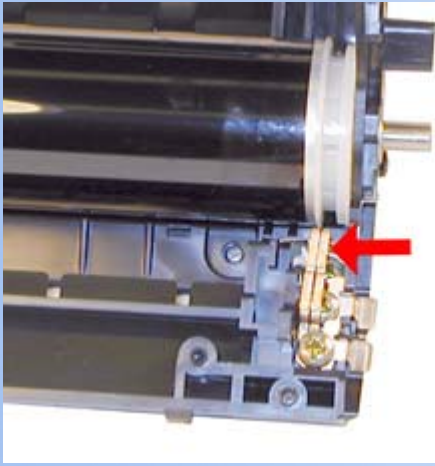
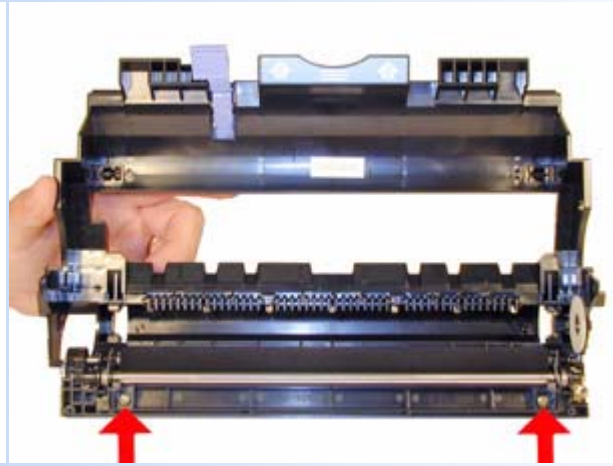
21. Install the cleaned cleaning roller assembly. Be careful not to damage the copper contacts when installing. See Figures 25 & 26
22. Replace the cover. Make sure the 4 tabs all snap into place. See Figure 27

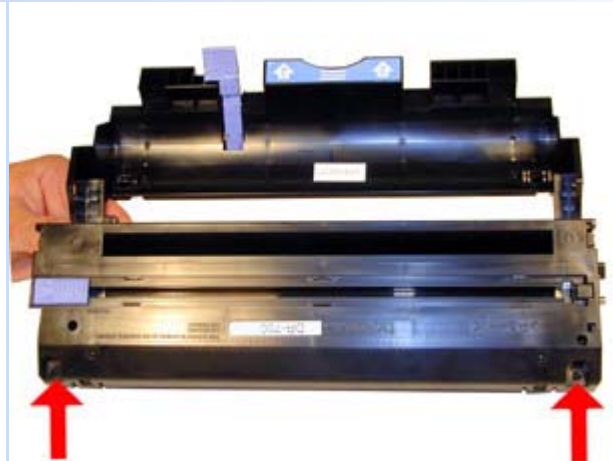
FIGURE 28

23. Install the top two screws. See Figure 28
