BROTHER® HL-2030 TN350/2000/2025 TONER CARTRIDGE REMANUFACTURING INSTRUCTIONS

REMANUFACTURING THE BROTHER HL-2030 TN350/TN2000/TN2025 TONER CARTRIDGES

By Mike Josiah and the Technical Staff at UniNet

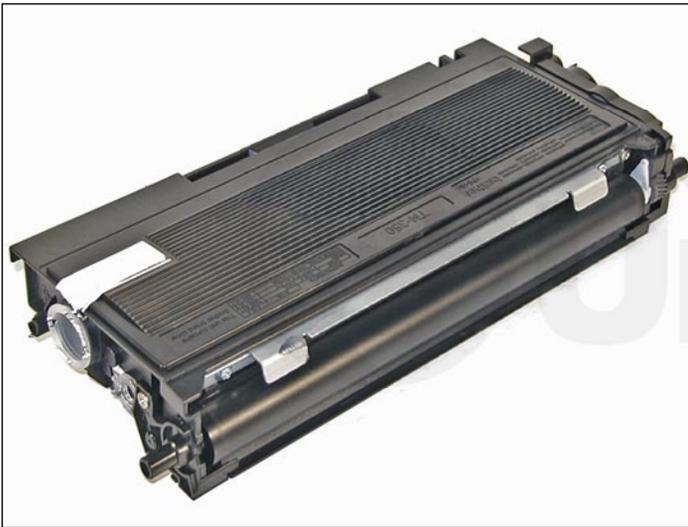
1. Vacuum the exterior of the cartridge.

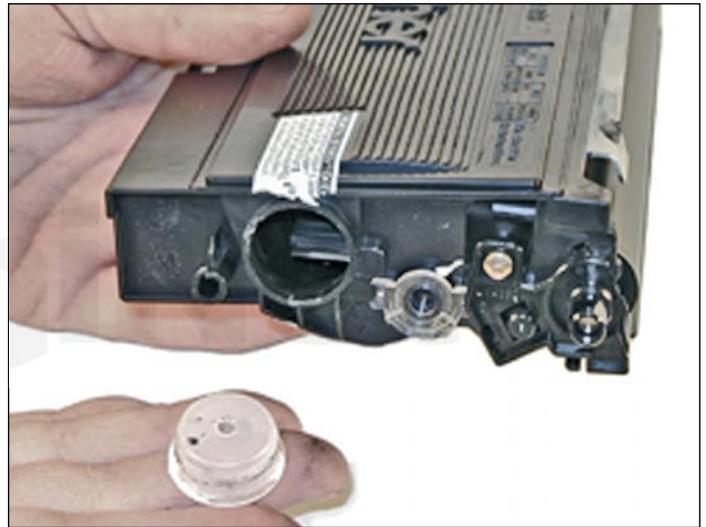
2. Remove the fill plug from the toner cartridge. Dump the remaining toner and vacuum/blow out the cartridge. Make sure that the gear area is clean. Leaving any toner in the teeth of the gears may cause a tooth to be damaged and cause a clicking noise. We have found it best to use compressed air to clean them out, but to also keep one hand over the gears to protect them.

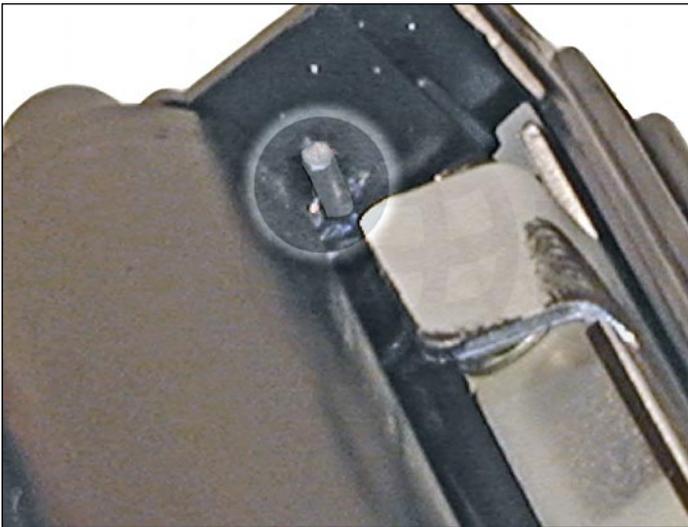
4. Locate the two tabs on the developer roller end plate, and pry off.

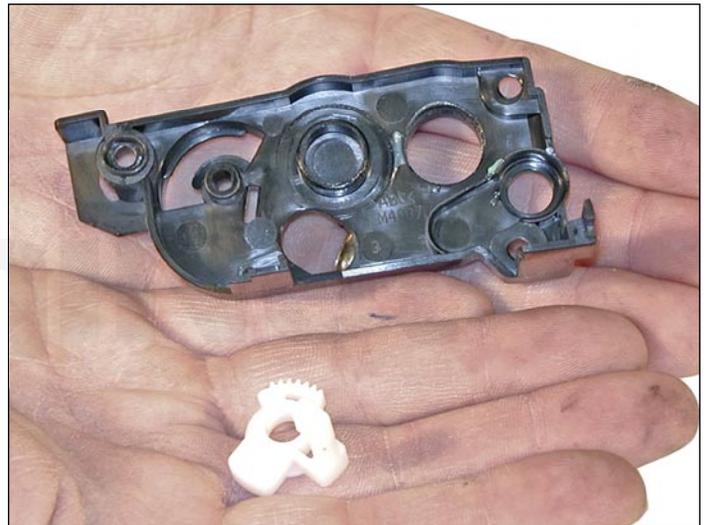
5. On the gear side, remove the three screws, and cover-plate.

6. A white flag gear will fall off as the plate is removed. This flag resets the printer when the cartridge is installed.

New starter cartridges do not have this flag gear. Until they are available, the starter cartridges cannot be remanufactured.

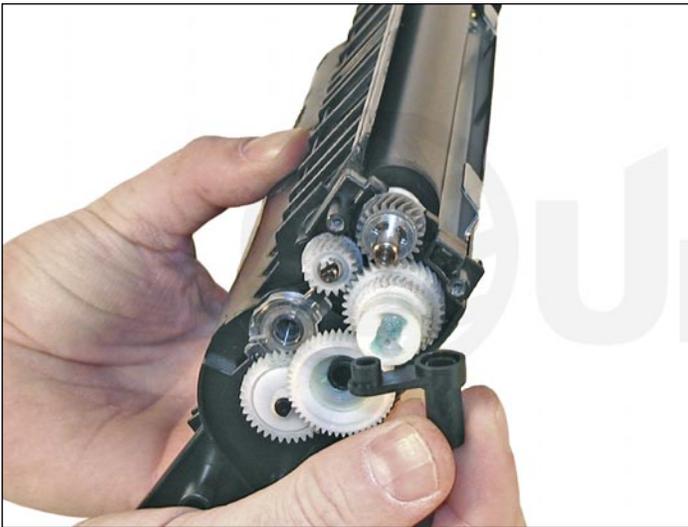
7. Remove the black plastic spacer from the developer roller shaft.

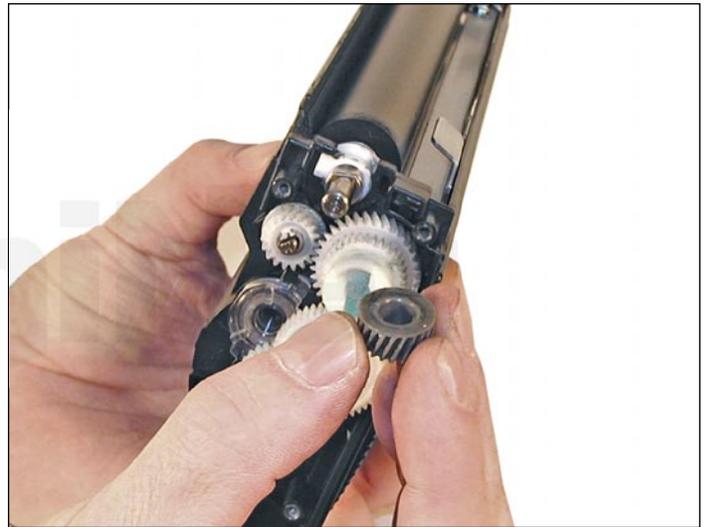
8. Remove the E-Ring and small gear.

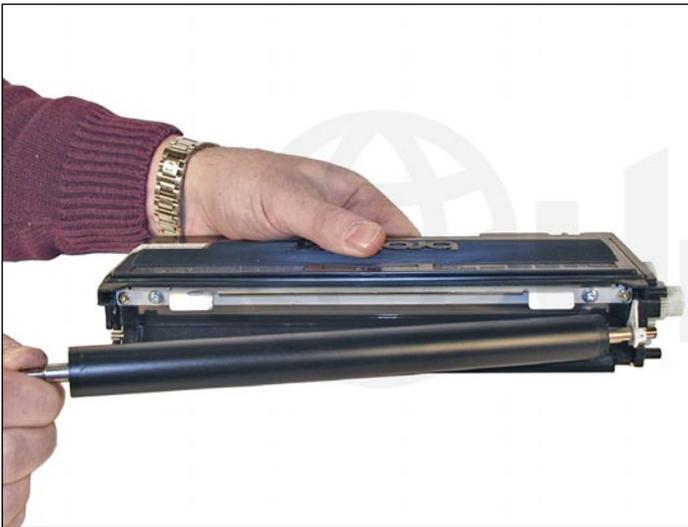
9. Remove the developer roller.

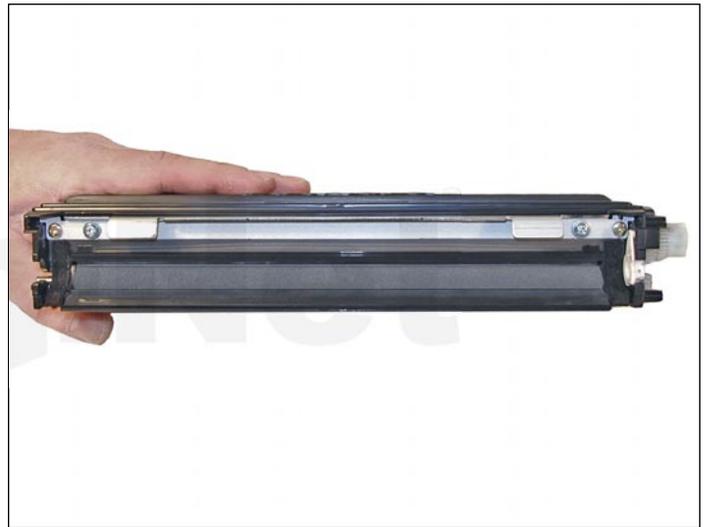
10. Vacuum the doctor blade and foam feed roller clean. We do not recommend that the doctor blade be removed and the developer roller felt seals will be disturbed. Once a new blade is available, great care will have to be taken not to tear the seals, causing a leak. The doctor blade can be easily cleaned by blowing the excess toner off, and wiping down with a lint free cloth. Be very careful not to leave any lint behind.

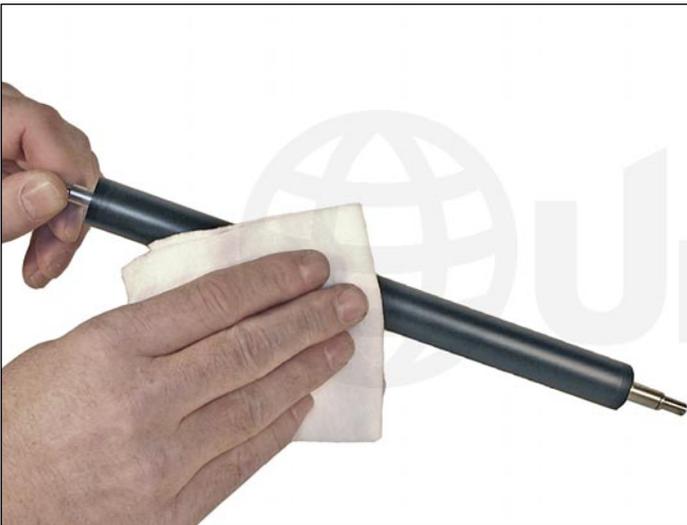
13. Clean the developer roller with a lint free cloth. Do not use any chemicals other than a dedicated cleaner for Brother rollers to clean the roller. A dry clean cloth will work fine.

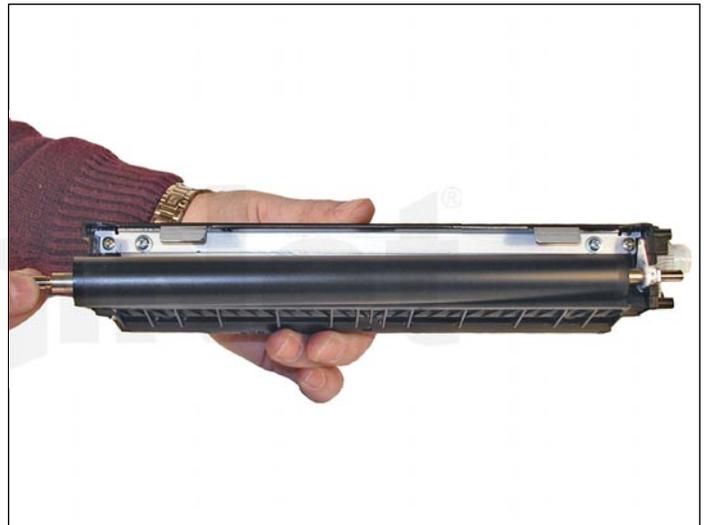
14. Re-install the developer roller long shaft side to the gear side.

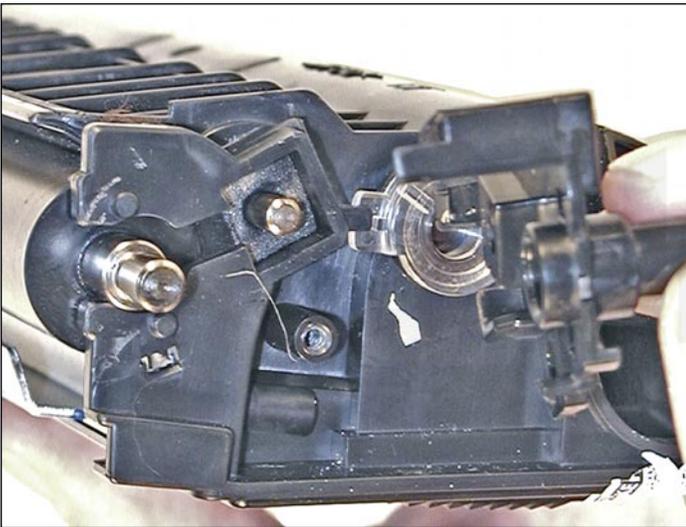
15. Install the small outside end plate and screw on the non-gear side.

Make sure the clear plastic plug for the optical sensor is locked in the proper position.

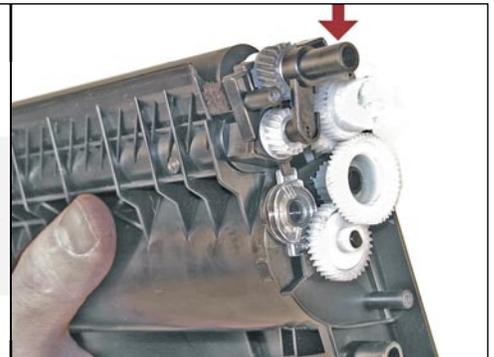
16. Install the developer roller gear, c-ring, and black axle.

Make sure all the other gears are meshing properly.

You may have to release the white spacer on the mag shaft to get the gear back on.

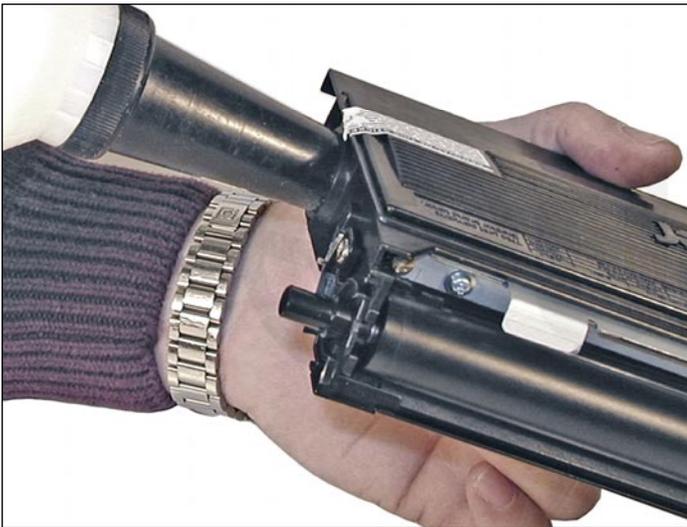
18. Fill the cartridge with toner for use in Brother 2030.

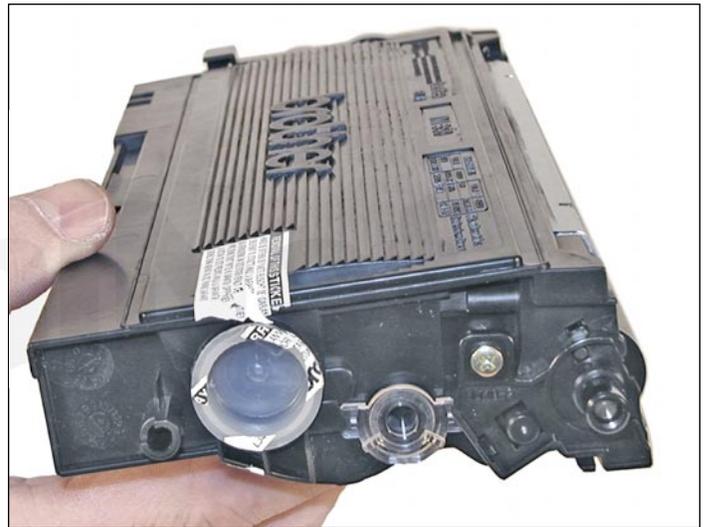
19. Replace the fill plug.

Wipe the cartridge down to remove any remaining toner dust.

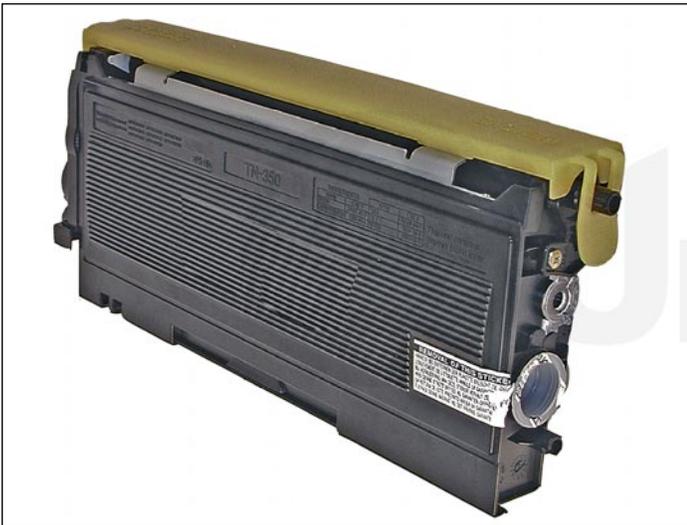
20. Install the developer roller cover.
