Panasonic KX-FL510, KX-FA76, KX-FA77 Toner Cartridges

DOC-0298

OVERVIEW

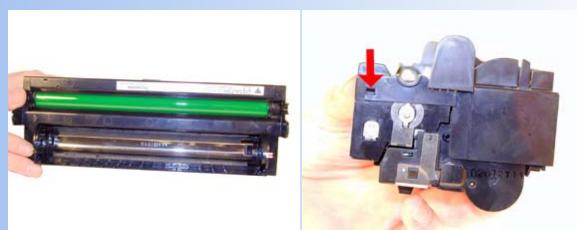
FIGURE 2 FIGURE 3

Vacuum the outside of the cartridge thoroughly, especially the exposed Toner Hopper. If the toner tube is still installed, remove it now. See Figure 2

- 2. With the small common screwdriver, release the two plastic tabs located on each end of the cartridge. See Figure 3.
- 3. Release the three plastic tabs located on the back edge of the toner hopper. The easiest way to do this is to slide the edge of the screwdriver into the edge of the seam, and work it along until all three tabs are released. See Figure 4.
- 4. Remove the top cover. See Figure 5
