SAMSUNG® SF-830

TONER CARTRIDGE REMANUFACTURING INSTRUCTIONS

REMANUFACTURING THE SAMSUNG SF-830 TONER CARTRIDGE

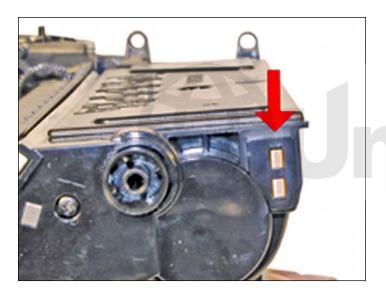
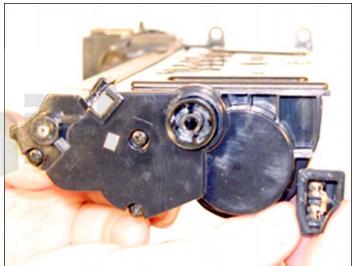
One of the error messages that these machines can display is "invalid cartridge." Since these cartridges do not have a chip, this made us curious, and we started to look around. On the gear side of the cartridge (see above pictures) there is a small black plastic piece with two metal contacts. This piece can be pried out, and inside (on the Samsung SCX-5312D6 cartridge), there is a 30K ohm resistor. The Xerox cartridge uses a 12K ohm resistor. It appears that the machine looks for a certain resistance to determine the cartridge brand. That is how it determines if the cartridge is correct or not. If the wrong resistor is present, the "Invalid cartridge" message will display. This is a very easy and inexpensive way to build cartridges for other companies. There are no different plastic molds or anything else and the cartridges could even have the same production line. At the end of the line, the cartridges could be funneled off into the last section where these small encoding parts are installed. Only the very end of the line would be different. Much less expensive than retooling the production line for each manufacturer. The resistor does not go bad; it does not blow as a fuse would. It seems only to be there for identification purposes.

The Samsung cartridge resistor has a color code of orange, black and gold. This code means the resistor has a value of 30K ohms at 5% tolerance. The Xerox cartridge resistor has a color code of brown, red, black and gold. This code means that the resistor has a value of 12K ohms at 1% tolerance.

Invalid cartridge: A non-Samsung cartridge is installed, or the encoder piece is missing.

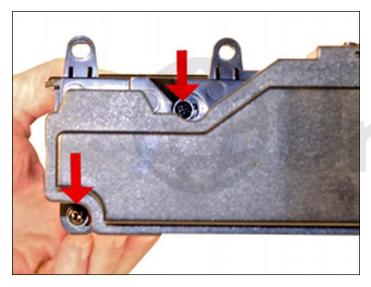
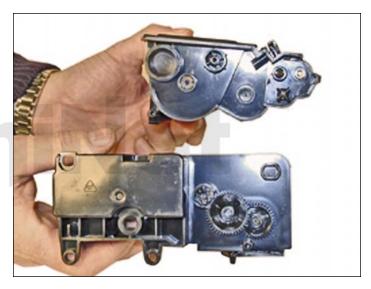
1. Remove the two screws located on the waste chamber.

Remove the waste chamber.

Be careful not to lose the gears.

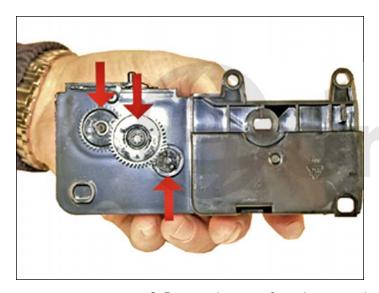
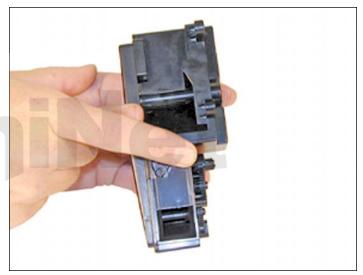
2. Remove the gears from the waste chamber and open the spring loaded cover.

Vacuum and blow out the waste chamber clean.

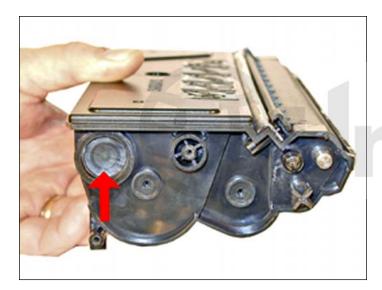
3. Remove the toner fill plug on the same side of the cartridge as the waste chamber. Dump the bulk of the remaining toner out of the cartridge. Vacuum/blow out the toner supply chamber clean. It is not necessary to get the cartridge completely clean now. As the developer roller needs to come out so the doctor blade can be cleaned, you will then have easy access to clean out the hopper.

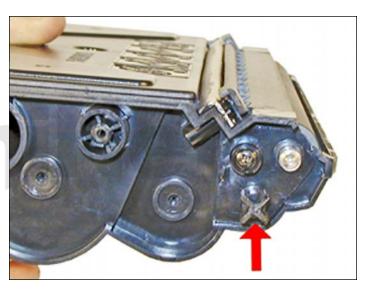
4. Remove the waste chamber drive gear.

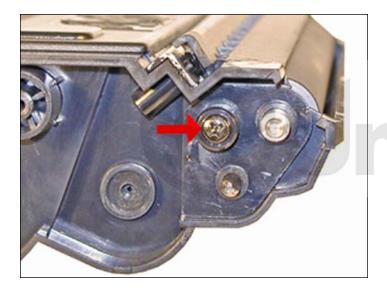
5. Remove the small developer roller screw and end cap.

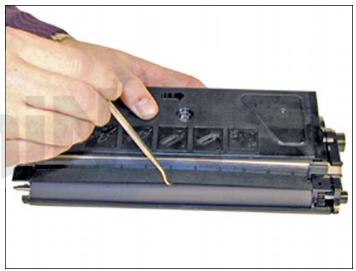
6. With a spring hook, bend up the middle of the developer roller cover, and remove from the cartridge. The cover has a small plastic tab that locks it in place on each side.

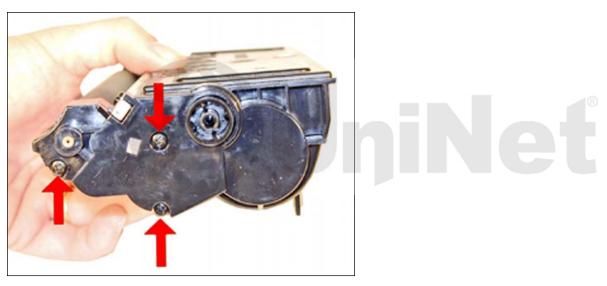
7. Remove the three screws from the opposite side end cap.

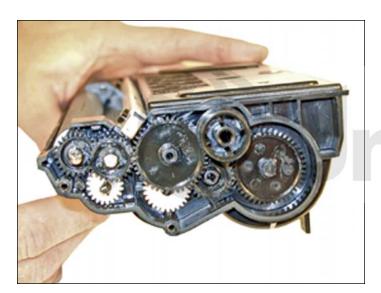
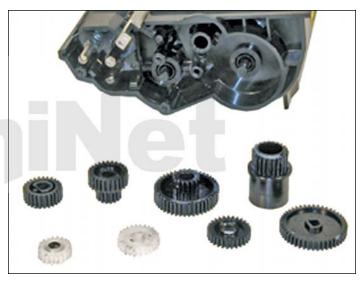
8. Note the location and placement of the gears and remove them.

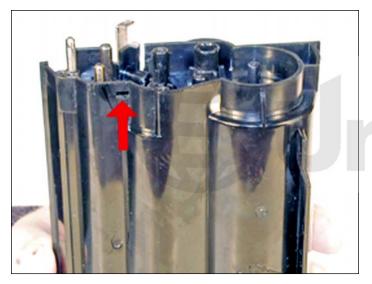
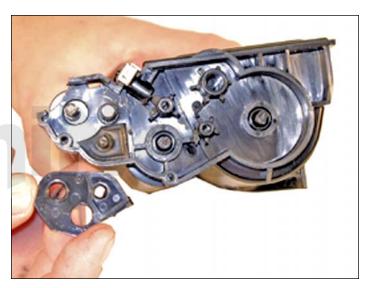
9. Remove the small internal end cap from the gear side, on the developer roller shaft. Although it is not necessary to remove this piece for the roller to come out; if it is not removed, it will bend, and most likely cause a leak. To remove it, press in on a small tab, and pry it out.

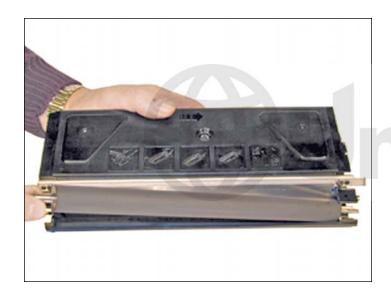
10. Lift the developer roller out of the cartridge.

Clean out all the remaining toner from the hopper.

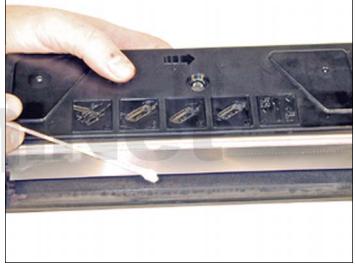
11. Clean the doctor blade. Unless new blades are available, we do not recommend that this blade be removed, as it is held in place by an adhesive foam seal under the blade. If the blade is pried up (not an easy thing to do) the blade will bend and become useless. Clean the blade with a cotton swab dampened with alcohol with the blade in place. Make sure that you do not drip any alcohol into the cartridge.

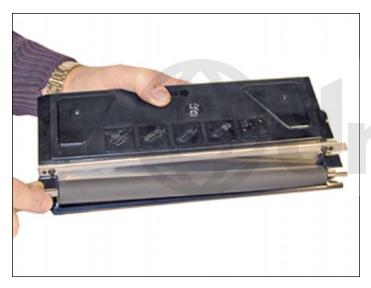
12. Install the developer roller.

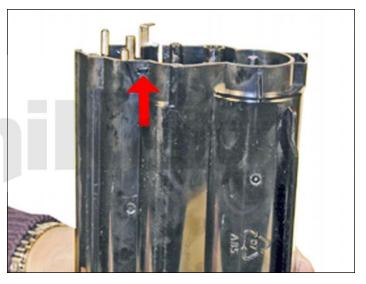
13. Install the small internal end cap.

Make sure it snaps in place.

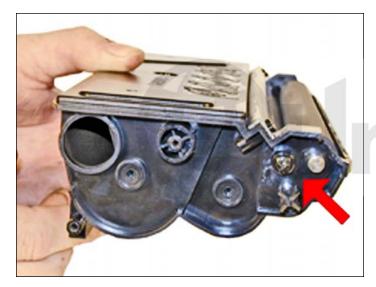
14. Install the developer roller end cap, screw, and drive gear on the waste chamber side. Clean the old grease off the gears and replace with new. We recommend white lithium grease be used.

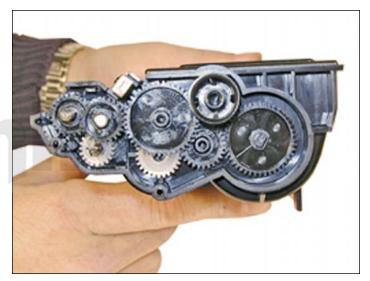
15. Install the gears, starting from left to right, and placing the inside gears first.

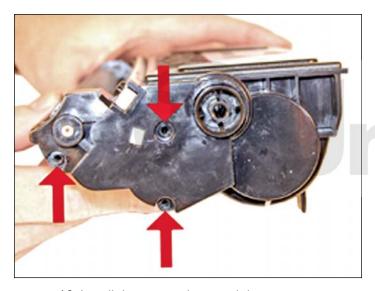
16. Install the gear end cap and three screws.

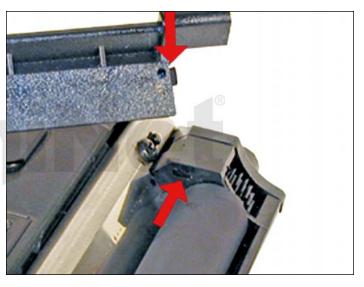
17. Install the developer roller cover in the same way it was removed. Do not bend it at too much of an angle, or it will stay bent.

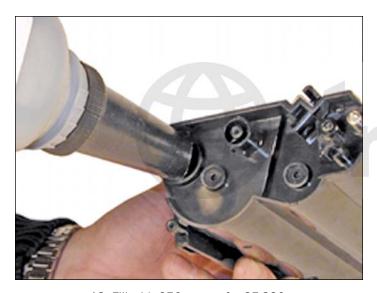
18. Fill with 250g toner for SF-830.

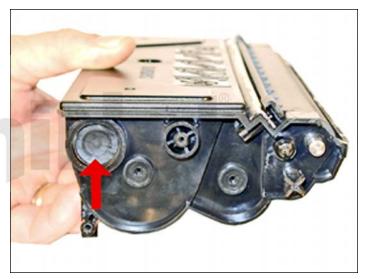
19. Install the fill plug and check for leaks.

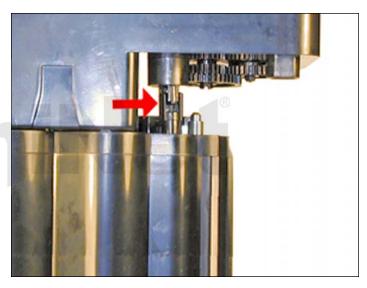
21. Make sure the waste chamber drive gear is meshed with the waste chamber gears.
