BROTHER® HL-2230 • 2240 • 2270 • 2280 • DR420 • 450 OPC DRUM CARTRIDGE REMANUFACTURING INSTRUCTIONS

REMANUFACTURING THE BROTHER HL-2280/DR420 OPC DRUM CARTRIDGE (DR2200 EUROPE/DR2225 ASIA)

By Mike Josiah and the Technical Staff at UniNet

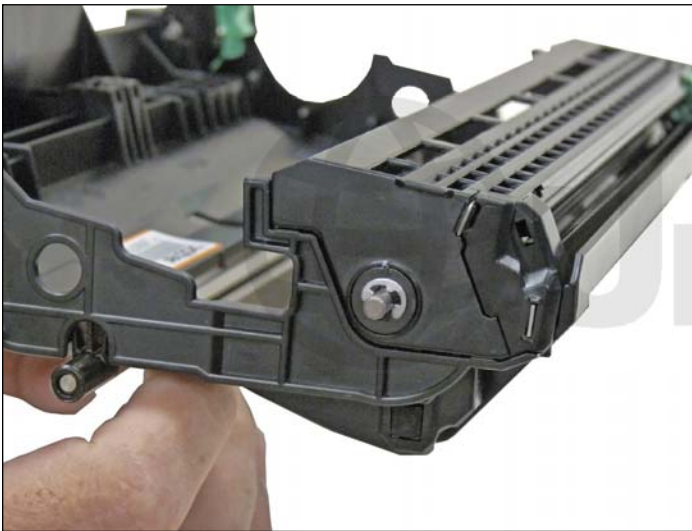
1. Remove the E-ring from the non-gear side of the drum axle shaft.

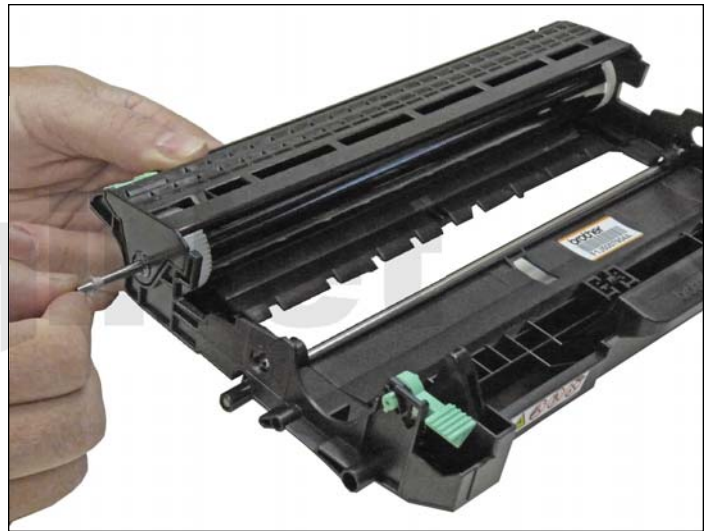
2. Remove the drum axle from the non-gear side of the drum. If you try to pull it out from the gear side, the shaft will jam up on the drum's ground contact, and damage the contact.

Solid black pages: Caused by a bad drum ground contact, probably from the drum axle shaft to the contact gear, inside the drum.

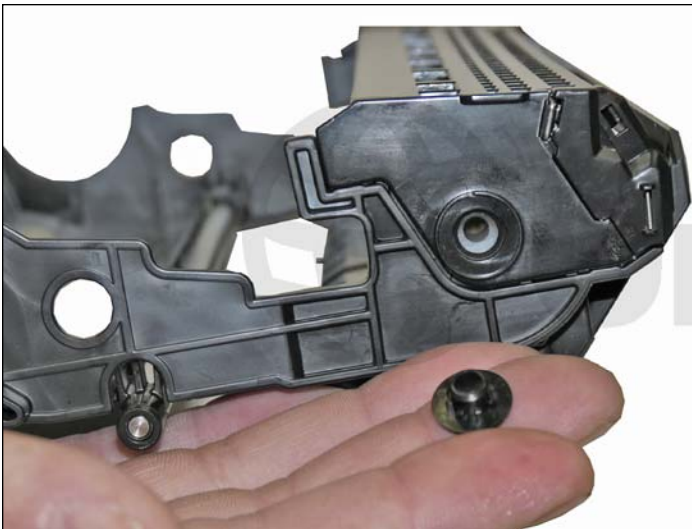
3. Be careful not to lose the round drum bushing, from the non-gear side of the cover!

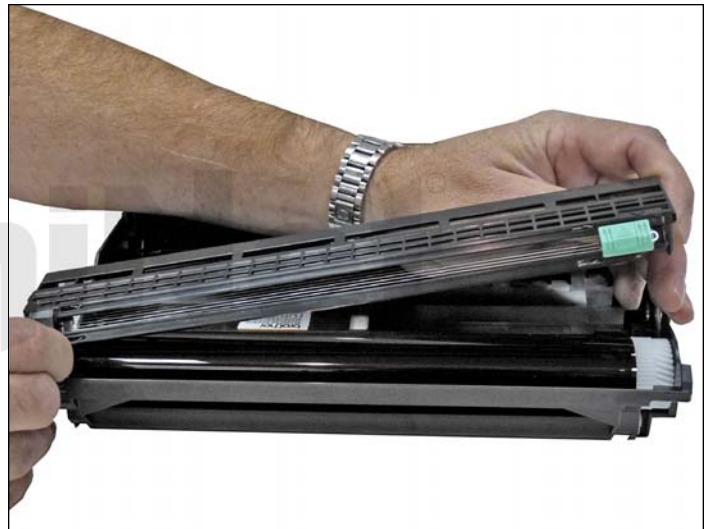
4. Carefully pry up and lift off the top cover/corona wire assembly from the cartridge.

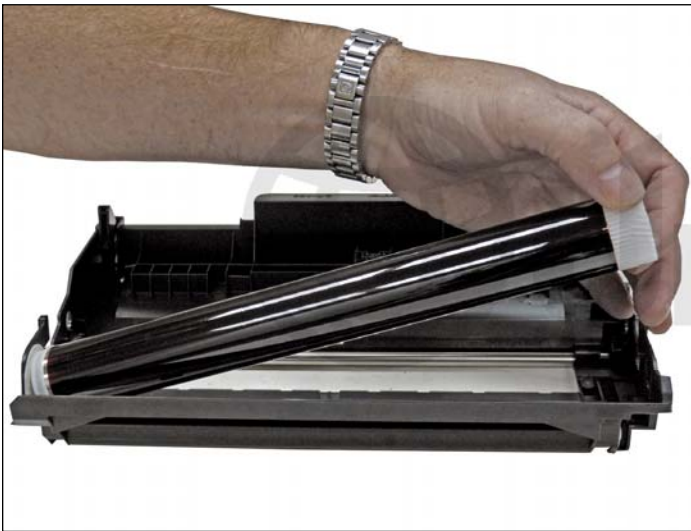
5. Carefully remove the drum.

Note that there is a one-piece drive gear, not two, as in previous Brother drum units.

The hub side is also spring loaded, and is not easily removable.

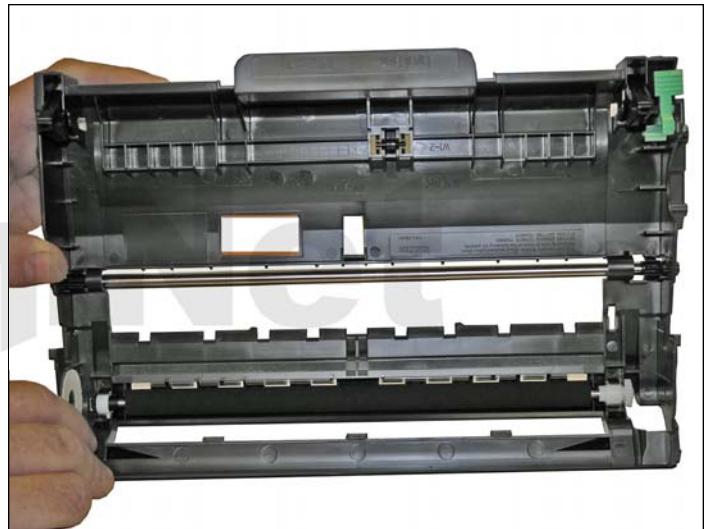
9. Install the transfer roller.

Make sure that both the white plastic bushings are clean.

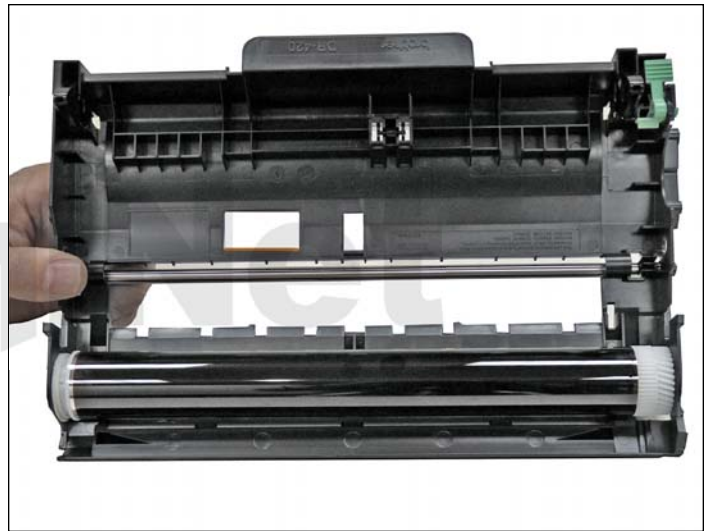
11. Install the drum, hub side first. You will have to compress the hub spring slightly for the drum to fit properly.

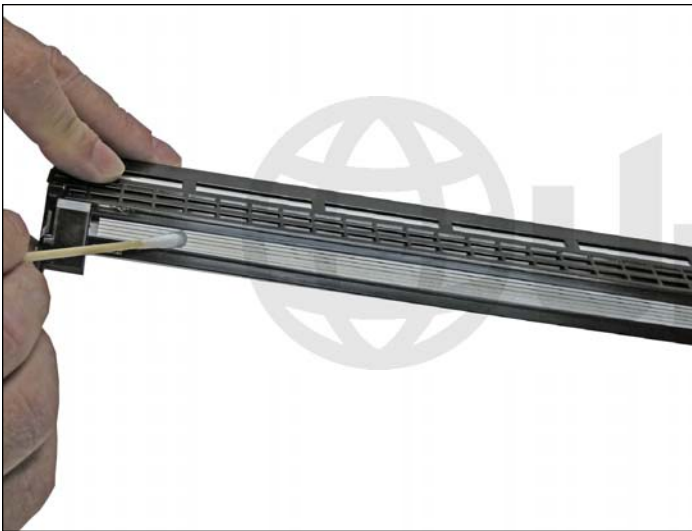
12. Clean the primary corona wire and grid with a cotton swab and alcohol.

Dark black vertical streaks: This is normally caused by either a dirty primary corona wire, or that the blue corona wire cleaner is not in its "home" position on the left side of the cartridge.

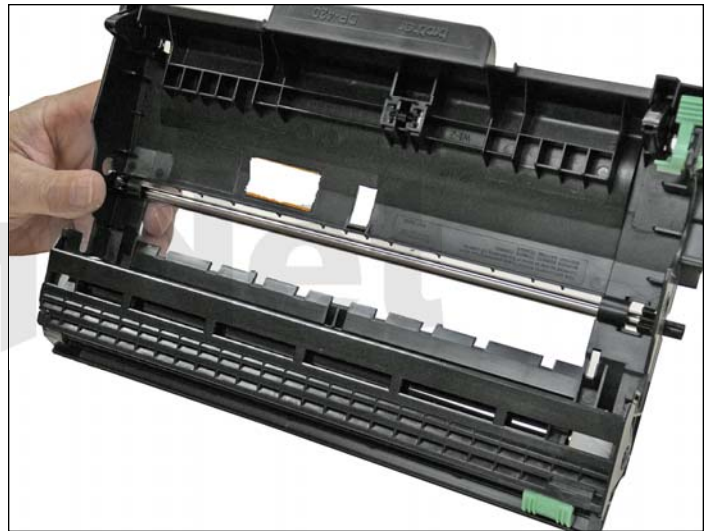
13. Install the top cover, pressing down so it snaps in place.
